DONAN[®]

MS. MYRNA WEBBER
COBBLEFIELD POINT CONDO ASSOCIATION
3858 THORNHILL CIRCLE
CHAMPAIGN, ILLINOIS 61822
CLAIM NUMBER: 3187291
DONAN PROJECT NUMBER: 13-18080194-0

SEPTEMBER 7, 2018

At your request, on September 5, 2018, a study was made on the condominium unit at the above-referenced address. The purpose of the study was to determine the cause of water intrusion on the exterior wall of the unit. Ms. Myrna Webber, a property manager with Devonshire Residential Management, was present to point out areas of concern and to provide firsthand information. Ms. Vicki Williams and Ms. Paula Goebel, members of the Cobblefield Point Condo Association board, were both present during the site visit. This letter, with the enclosed photographs, is the report of my findings and conclusions.

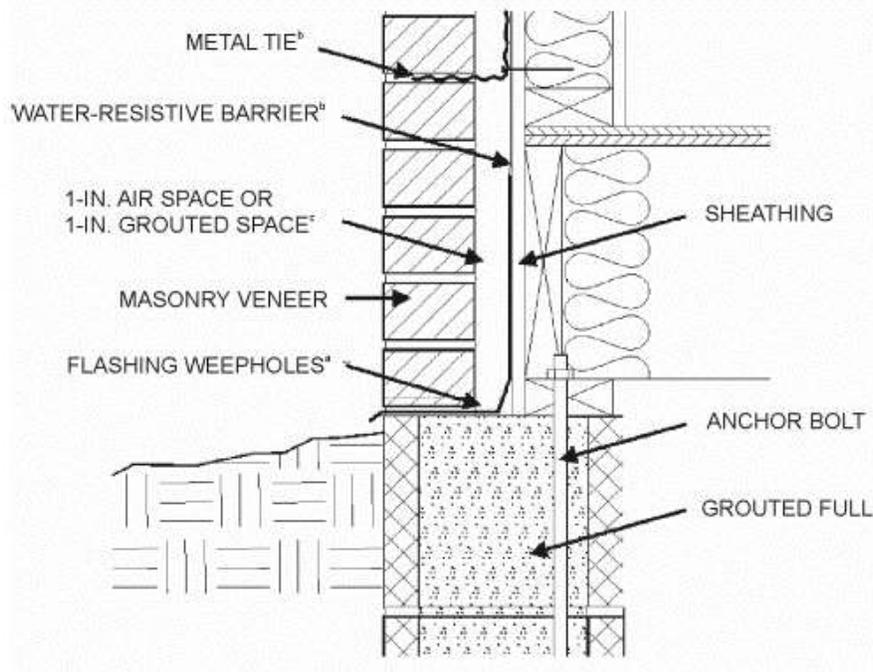
Figure 1: Brick Veneer Construction

Table R703.7.4 of the 2012 IRC states, “The veneer shall be separated from the sheathing by an air space of a minimum of 1 inch (25.4mm) but not greater than 4.5 inches (114mm).” Technical Note 28 from the BIA also requires that an air space between the brick veneer and exterior wall sheathing be provided. Providing an adequate air space and keeping this space free from construction debris and mortar are crucial to providing a path for drainage of absorbed or trapped water to the base of the wall.

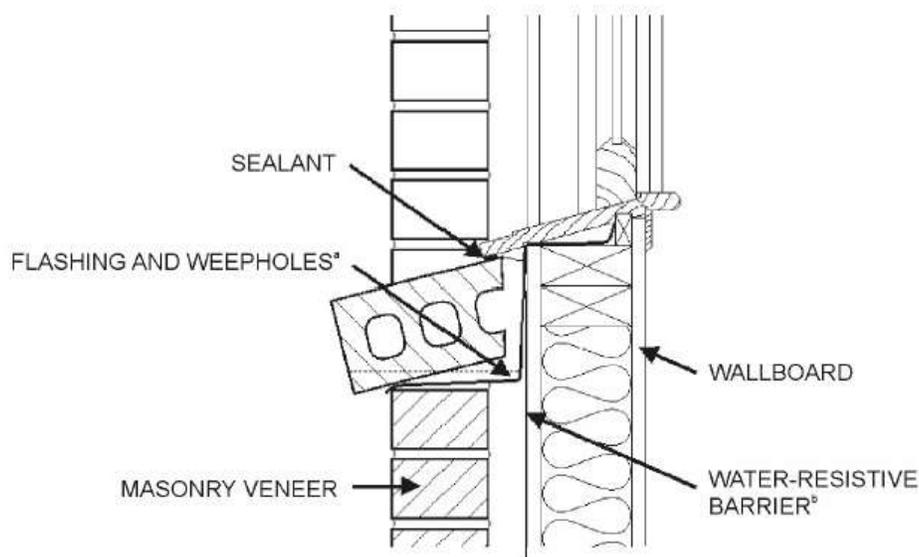
Figure 2: Flashing Detail at Window Sill

The primary function of a windowsill is to direct water away from the structure. The Brick Industry Association (BIA) specifies that masonry windowsills should slope down away from the building at a minimum angle of 15 degrees from horizontal and extend a minimum of 1 inch beyond the exterior face of the wall (Figure 2).¹ This equates to a slope of approximately 28 percent.

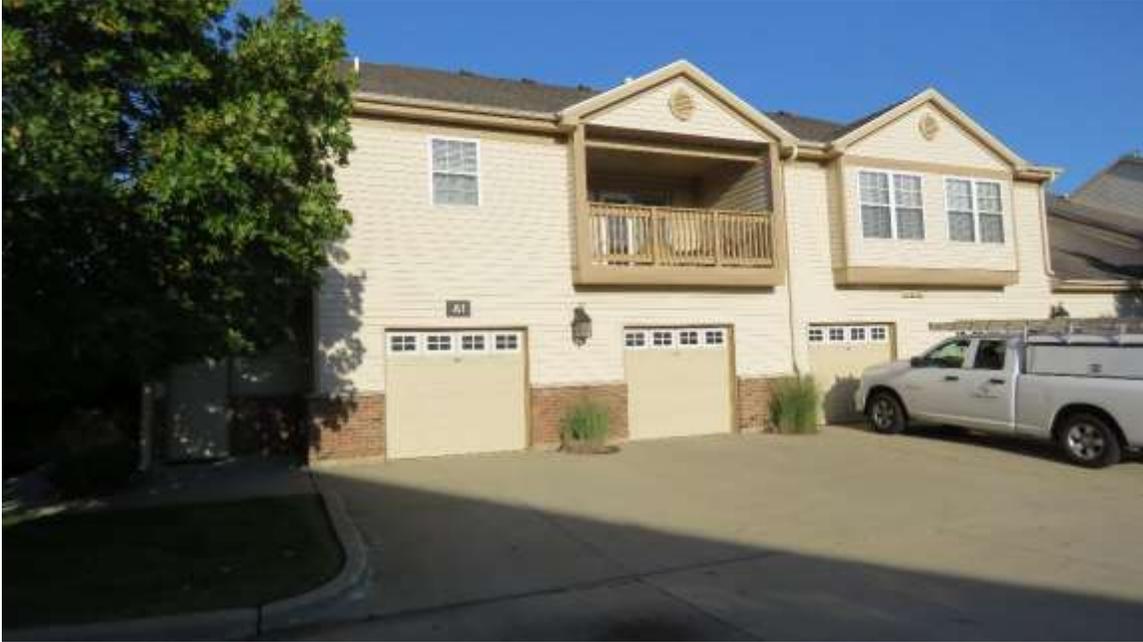
Photograph 1: East elevation faces Thornhill Circle.

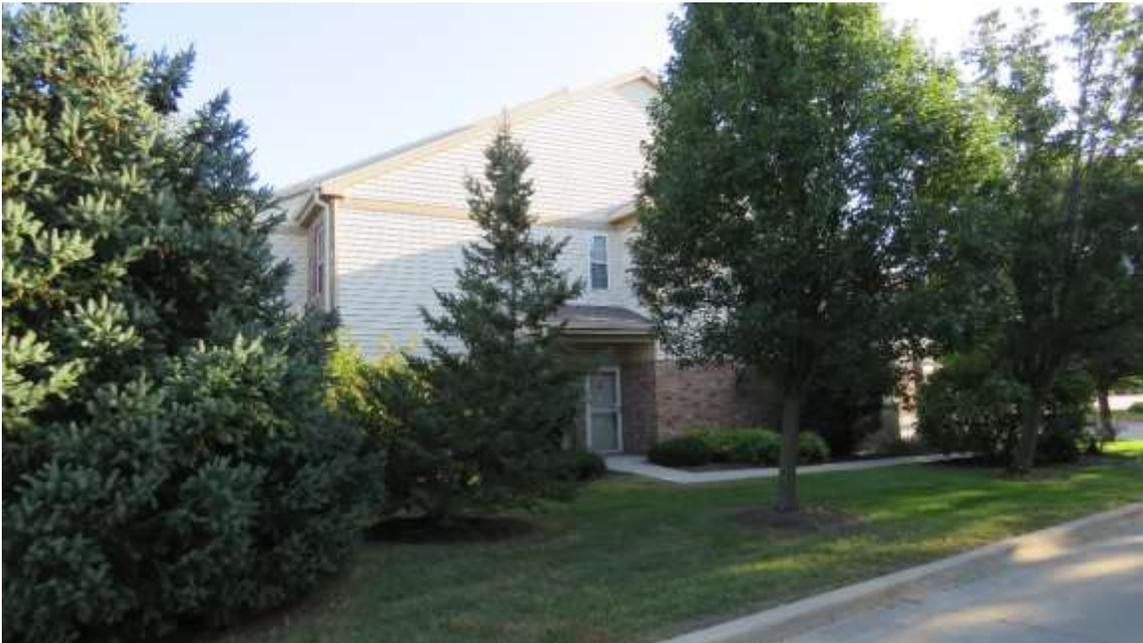
Photograph 2: South elevation faces Thornhill Drive.

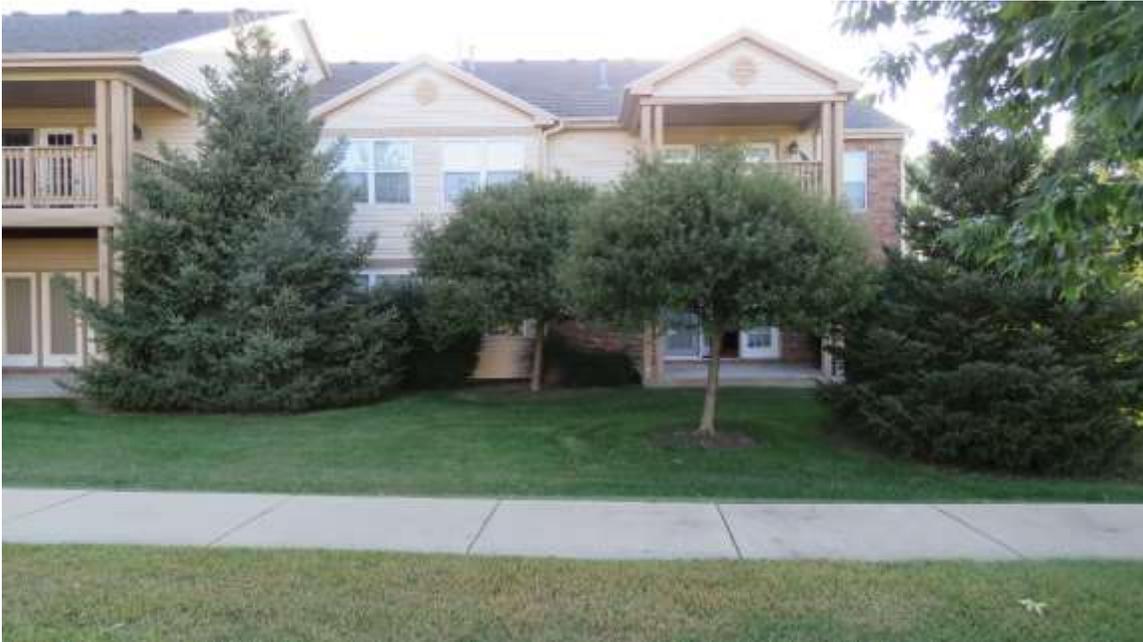
Photograph 3: West elevation faces Cobblefield Drive.

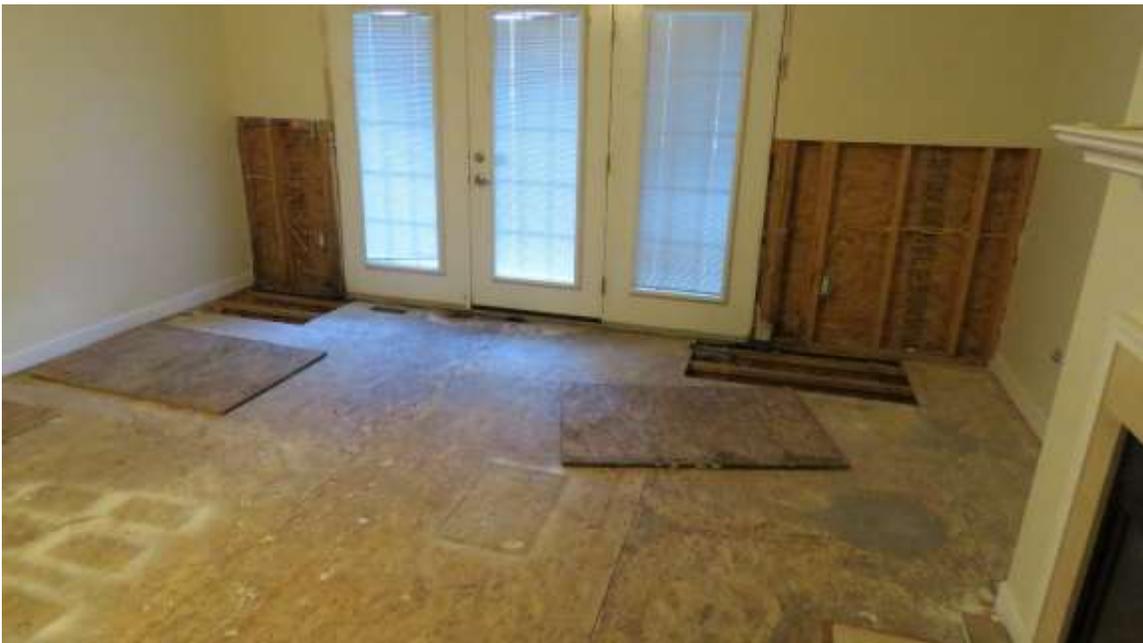
On the west wall of the living room, the lower 24 inches of drywall and portions of the subfloor have been removed to the right (north) and left (south) of the patio doors (Photograph 4). The exterior sheathing consists of $\frac{7}{16}$ -inch oriented strand board (OSB) over nominal 2-inch by 4-inch (2x4) wall framing. The exterior sheathing, walls studs, bottom plate, and the header joists in the crawlspace are discolored with apparent fungal growth. The exterior wall sheathing at the lower right corner to the left of the doorframe is deteriorated, exposing the fabric house wrap on the exterior of the OSB (Photograph 5). The framing in the bottom left corner of the door is deteriorated with partial section loss of the doorframe and wall framing (Photograph 6). Near the operational section of the patio doors, the OSB subfloor is discolored and deteriorated with a

Photograph 4: Overview of the west wall in the living room.

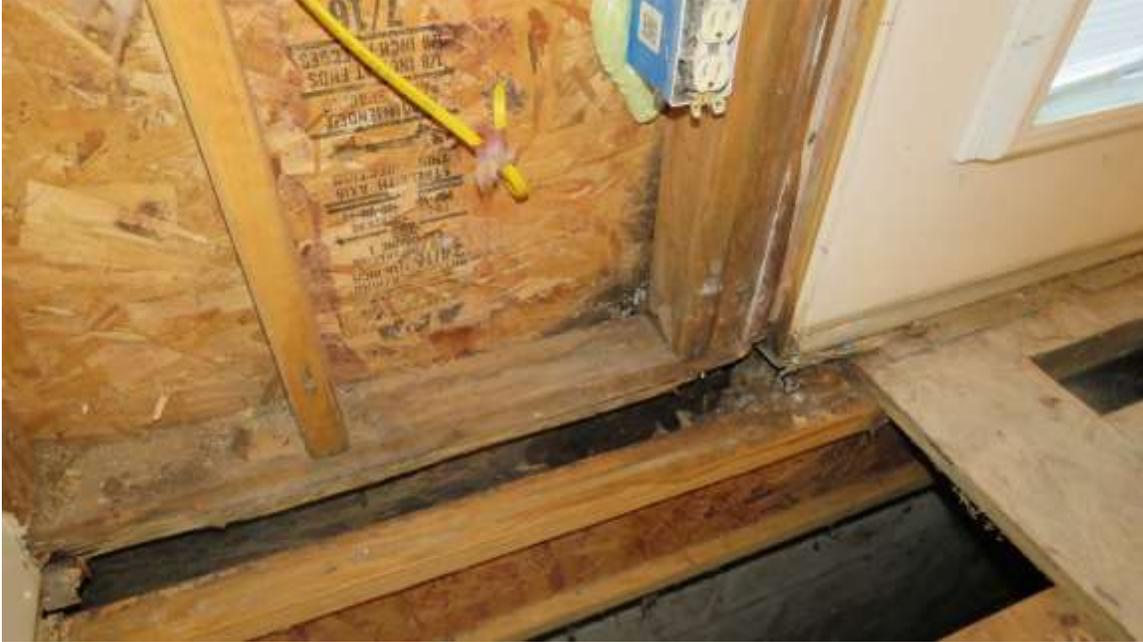
Photograph 5: Deterioration and discoloration of the wall to the south of the patio doors.

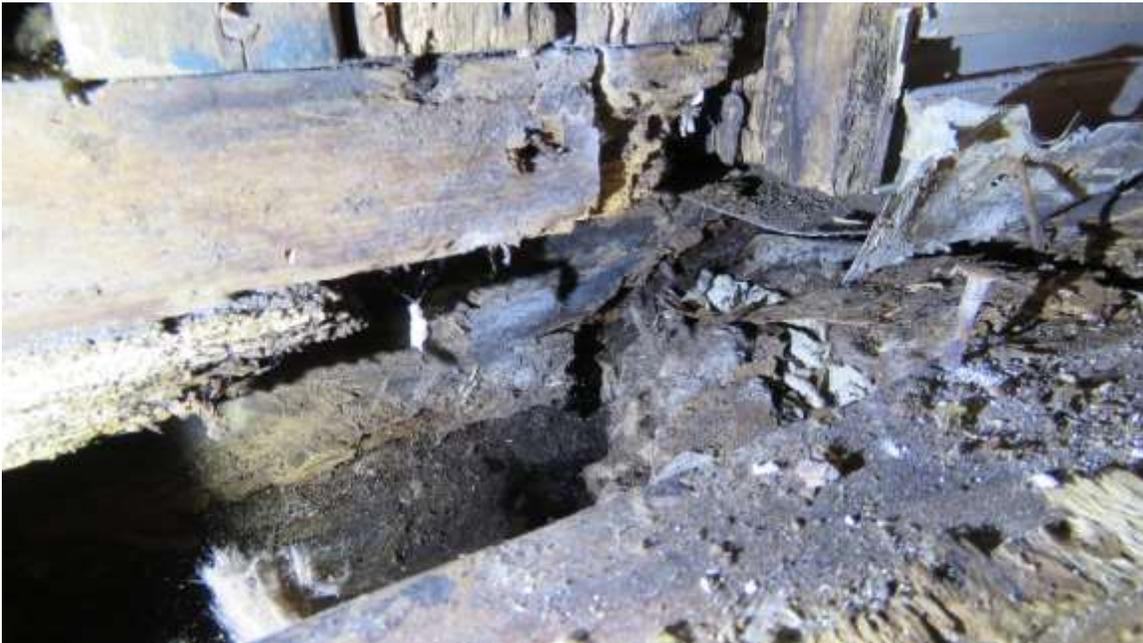
Photograph 6: Deterioration of the bottom plate and framing around the door.

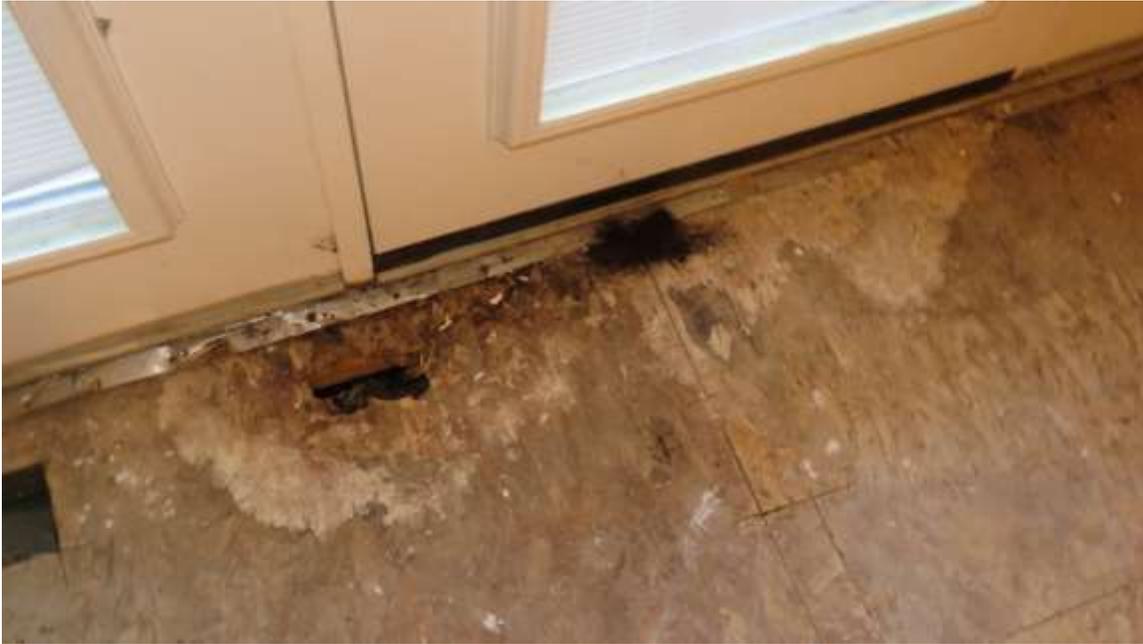
hole, approximately 3 inches in diameter, at the left jamb of the door (Photograph 7). To the right of the door, the lower 6 inches of the studs and the bottom plate are discolored with minimal deterioration or section loss relative to the left side of the door (Photograph 8). The header joist is discolored and deteriorated below the subfloor.

Photograph 7: Deterioration of the subfloor in front of the doors.

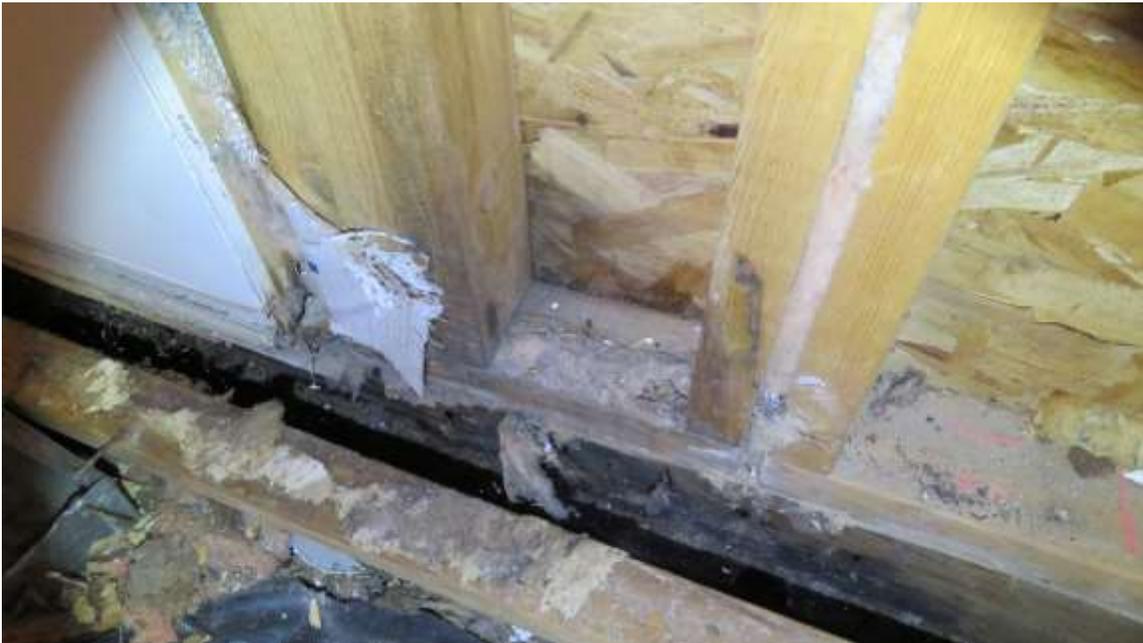
Photograph 8: Discoloration and deterioration of the framing to the north of the patio doors.

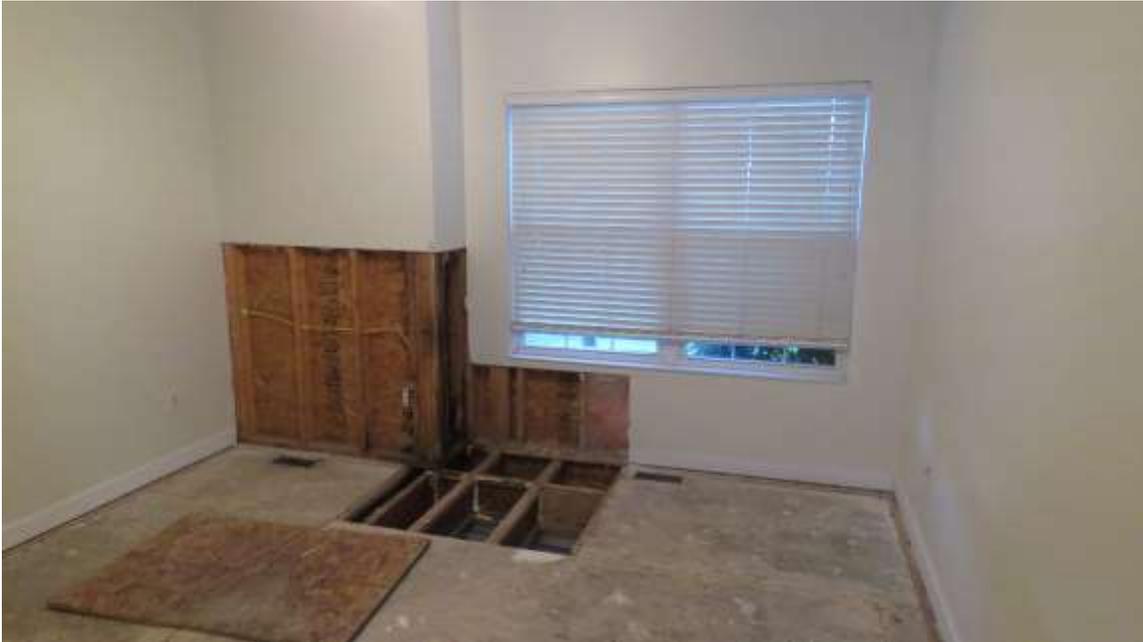
In the adjacent bedroom to the north of the living room, the lower 24 inches of drywall have been removed along the south half of the west wall, and a portion of the subfloor is removed at the center of the west wall (Photograph 9). The OSB on the interior corner framing is discolored on the south side of the corner and discolored with full section loss on the north side (Photographs 10 and 11). The 2x4 studs on the north side of the corner are deteriorated with partial section loss (Photograph 12). The exposed fabric house wrap is over brick veneer on the left and vinyl siding on the right. Daylight can be seen in the gap between the exterior claddings (Photograph 13). The floor joists are discolored around the interior corner (Photograph 14).

Photograph 9: Overview of the west wall in the adjacent bedroom to the north.

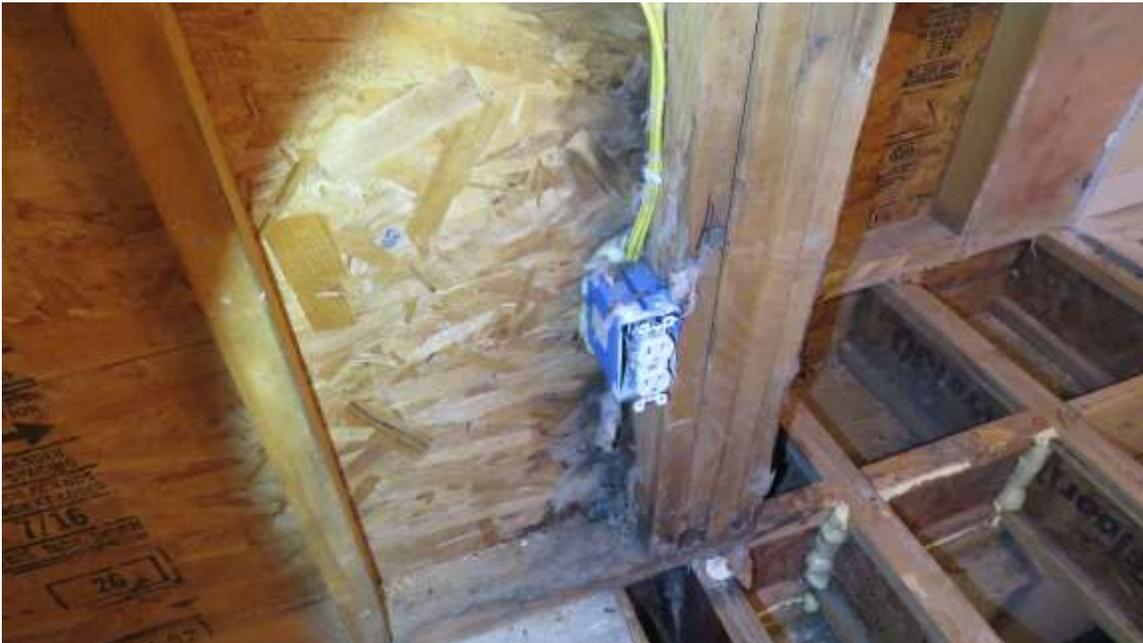
Photograph 10: Discoloration and deterioration of the wall framing to the south of the interior corner.

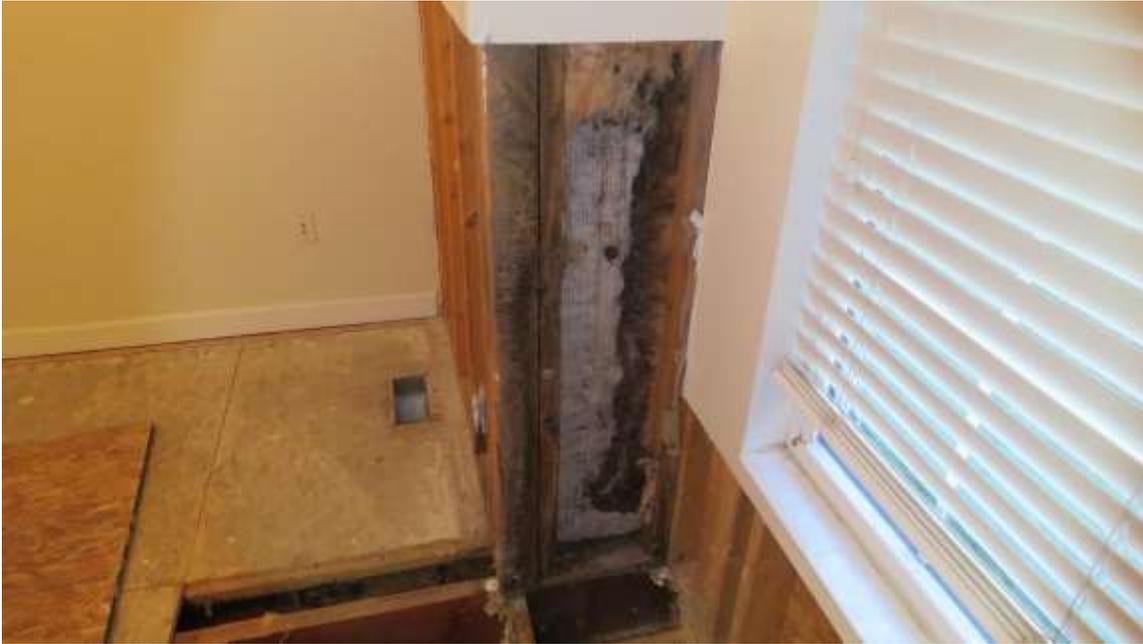
Photograph 11: Discoloration and deterioration of the framing and sheathing to the north of the interior corner.

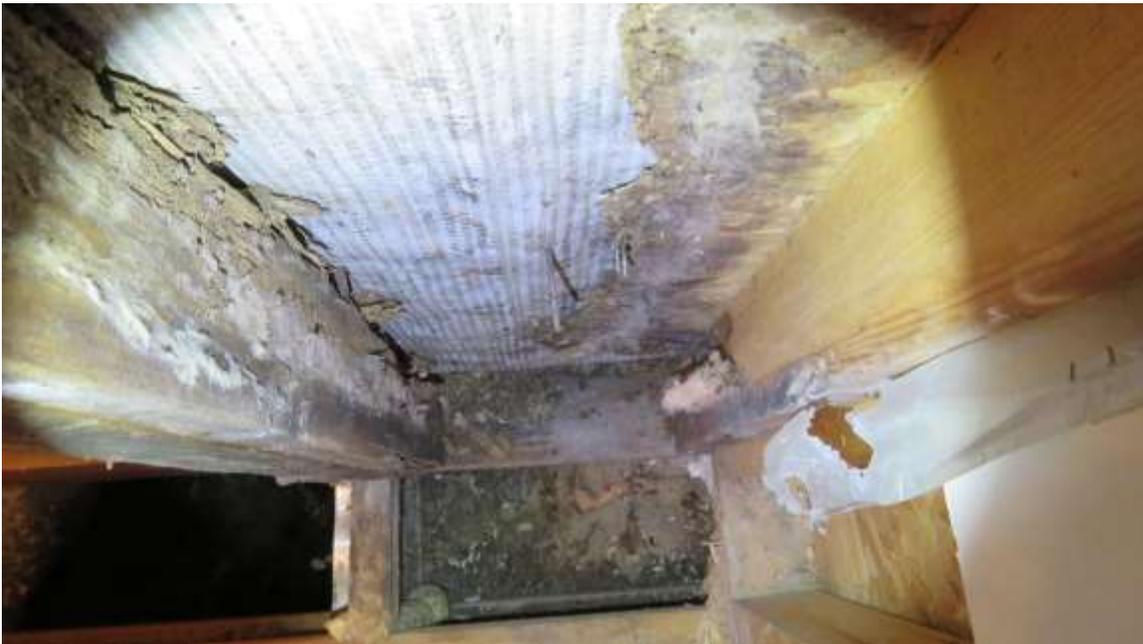
Photograph 12: Deterioration and section loss of the sheathing and framing.

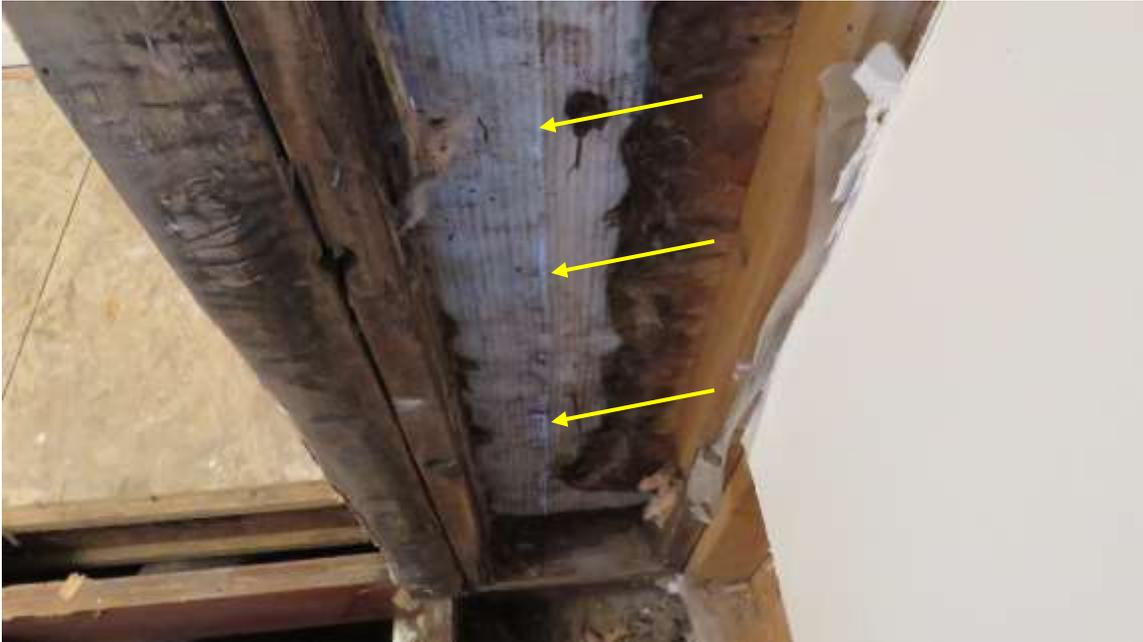
Photograph 13: Daylight exposure between the brick and vinyl siding.

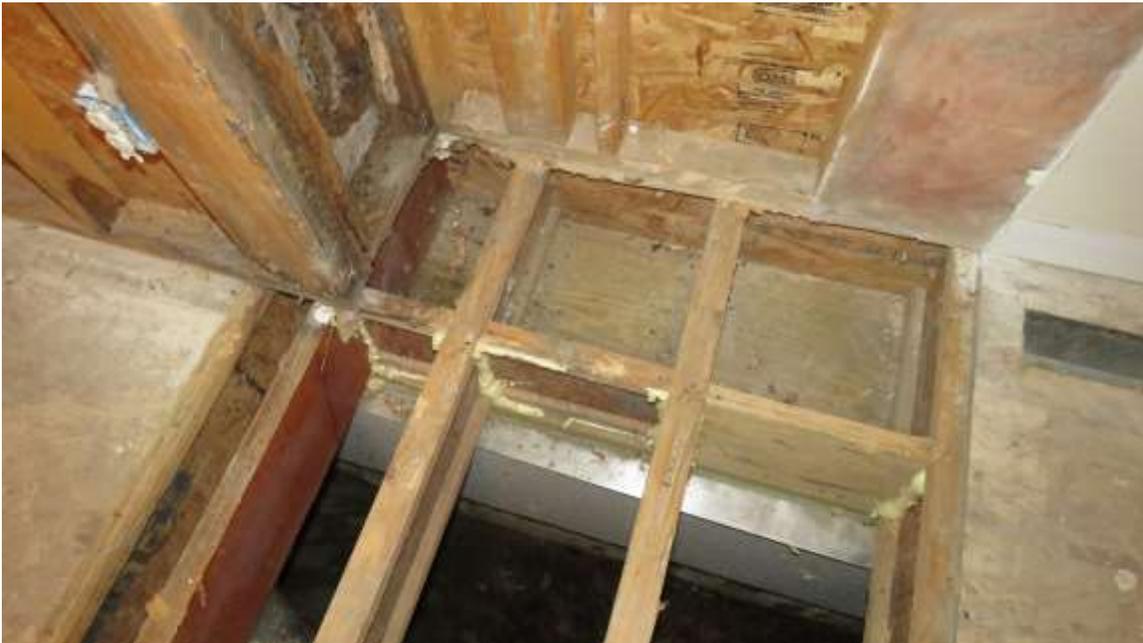
Photograph 14: Discoloration and deterioration of the floor framing.

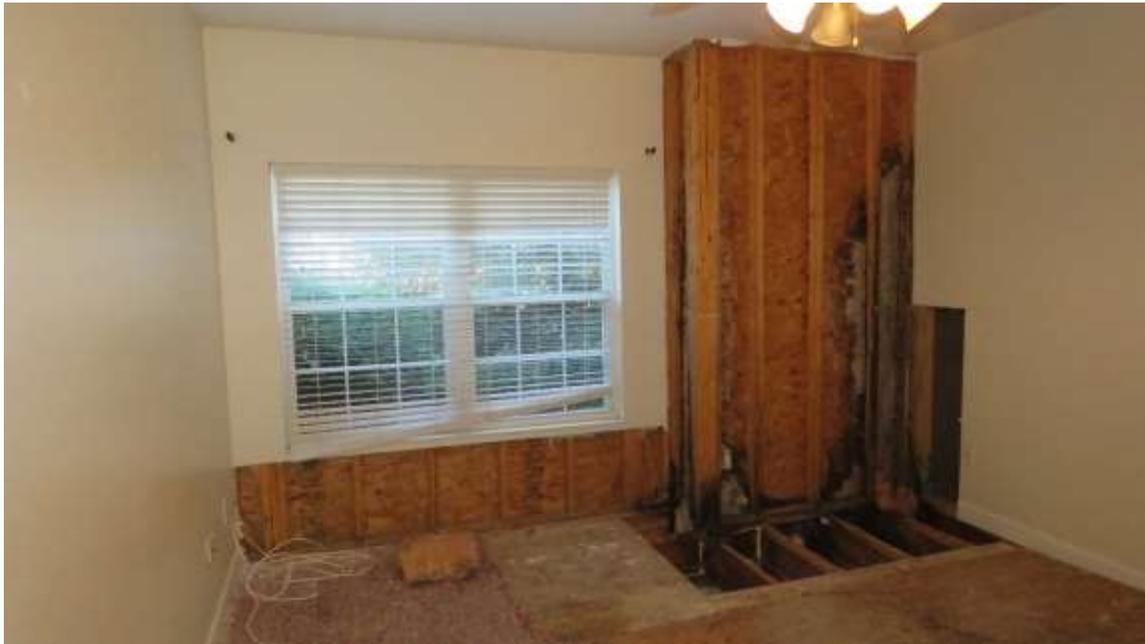
In the adjacent bedroom to the north, the lower 18 inches of drywall are removed on the south half of the west wall, the drywall is completely removed on the north half of the west wall, and a portion of the subfloor under the north half of the west wall is removed (Photograph 15). On the south side of the interior corner, the OSB is discolored and deteriorated with full section loss, exposing the fabric house wrap. Daylight exposure is noted between the brick and vinyl siding (Photograph 16). The top edge of the brick veneer has a metal flashing cap that terminates at the south end of the wall (Photograph 17). At the base of the wall, the bottom plate is deteriorated and missing, and the plywood covering the bottom of the overhanging floor section is displaced (Photographs 18 and 19). On the north side of the interior corner, the OSB is discolored at the top left and the top right corners of the wall, both at the same height as the deterioration on the south side of the interior corner (Photograph 20). The discoloration in the top left corner is light with apparent fungal growth but minimal deterioration. The discoloration in the top right corner is dark with deterioration and full section loss of the OSB, exposing the fabric house wrap and the brick veneer (Photographs 21 and 22). At the base of the wall, the framing is deteriorated with full section loss of the west end of the floor joists intersecting the interior corner, full section loss of the bottom plate at the left and right ends of the wall section, full section loss of the floor joist webbing on the header joist, and full section loss of the top chord of the header joist at the north end of the wall (Photographs 23 and 24).

Photograph 15: Overview of the west wall in the north end bedroom.

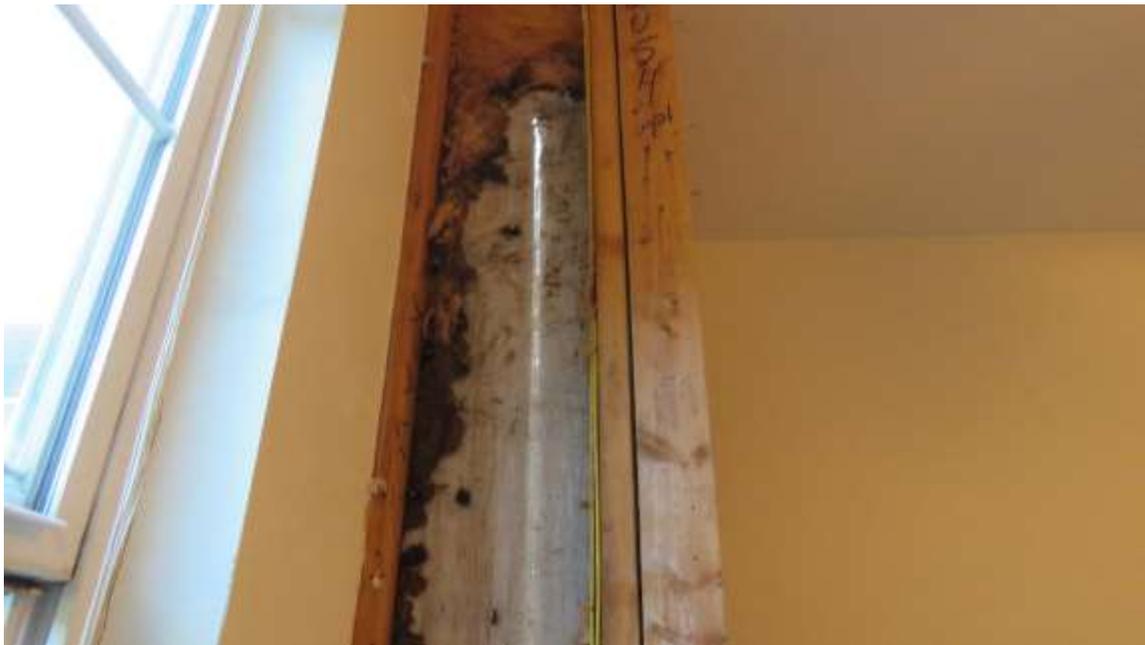
Photograph 16: Daylight exposure between the vinyl and brick veneer.

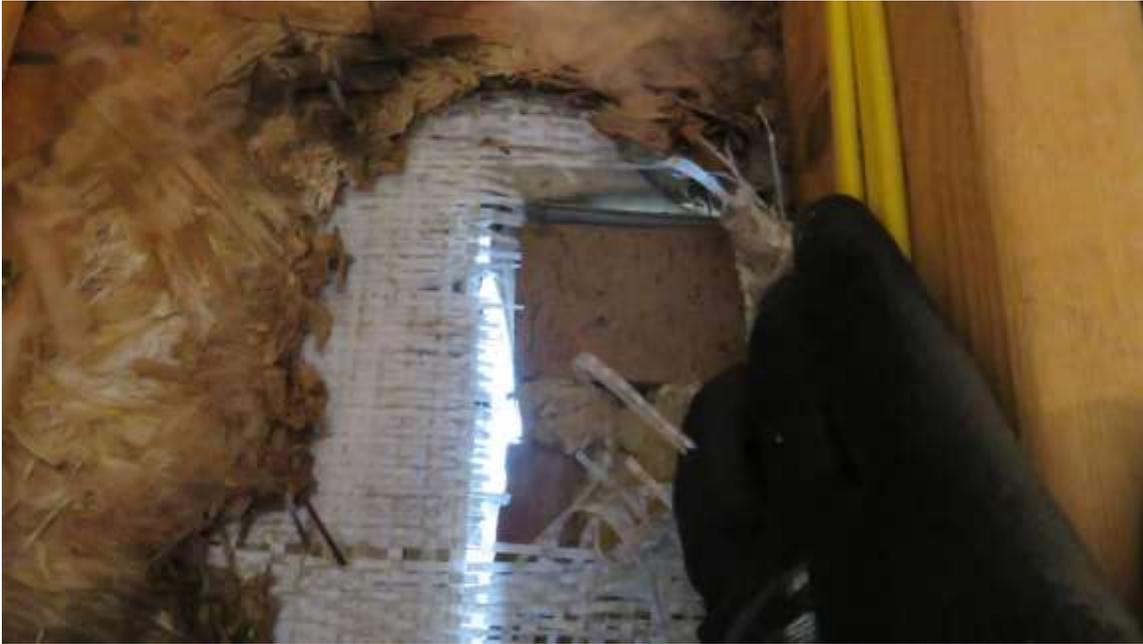
Photograph 17: Top of the brick veneer and the metal flashing cap.

The flashing cap on the wall should have a minimum of a 15-degree slope away from the outer wall, and the end of the flashing should be turned upward to prevent water from shedding off the ends into the end wall framing. Additional flashing, and the use of butyl tape, can prevent water intrusion at the end walls.

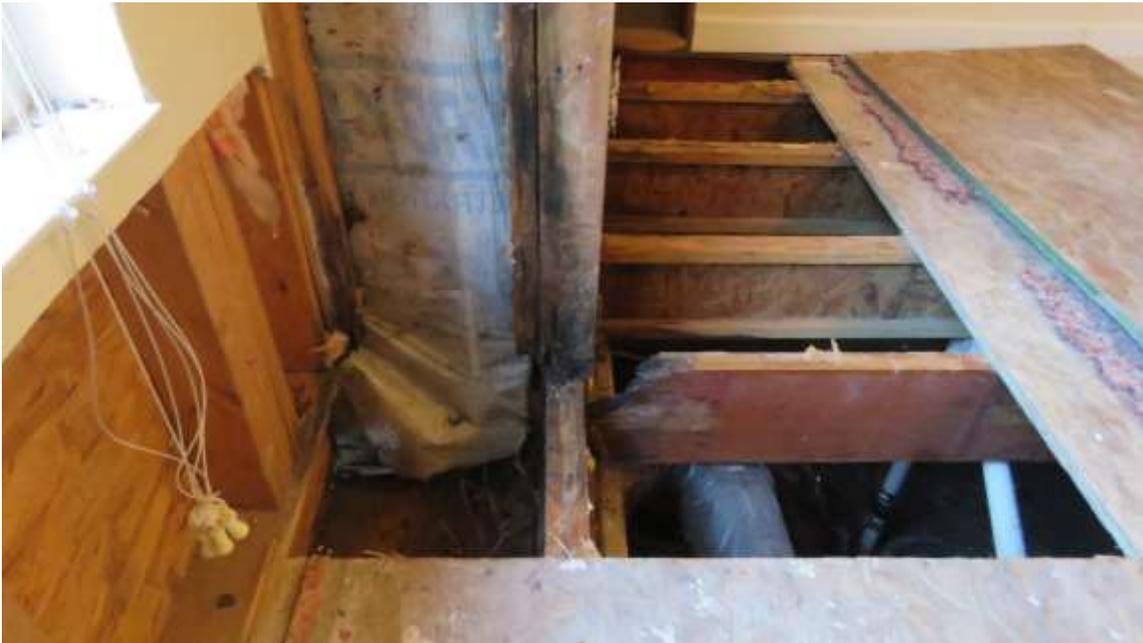
Photograph 18: Deterioration of the subfloor and floor framing. Note the lack of a bottom plate on the wall.

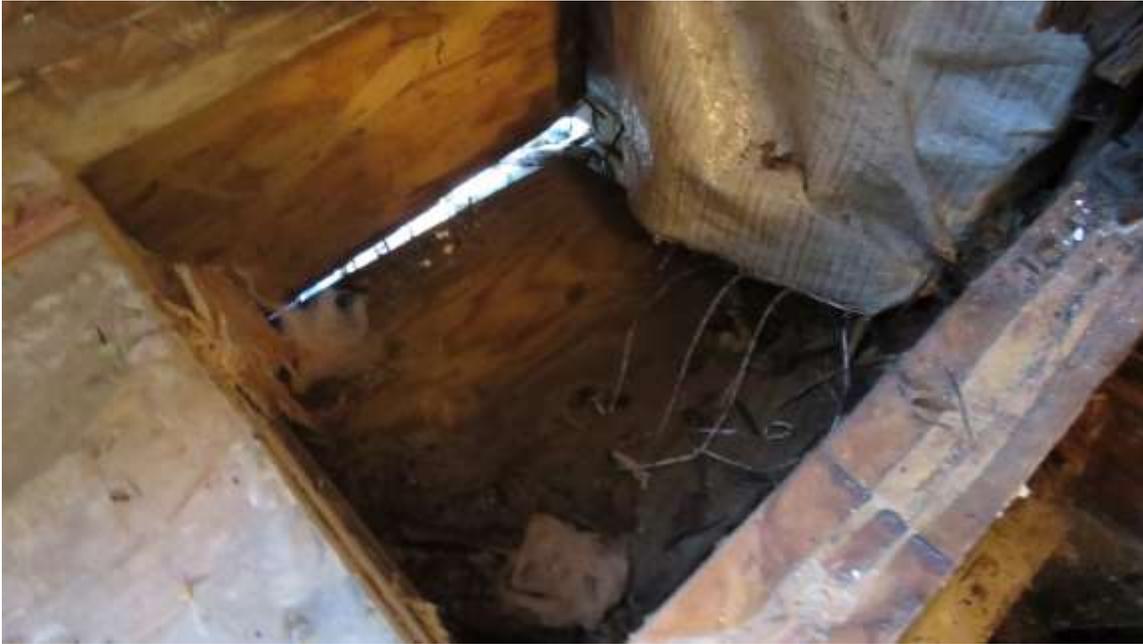
Photograph 19: Displacement and deterioration of the floor covering on the overhang.

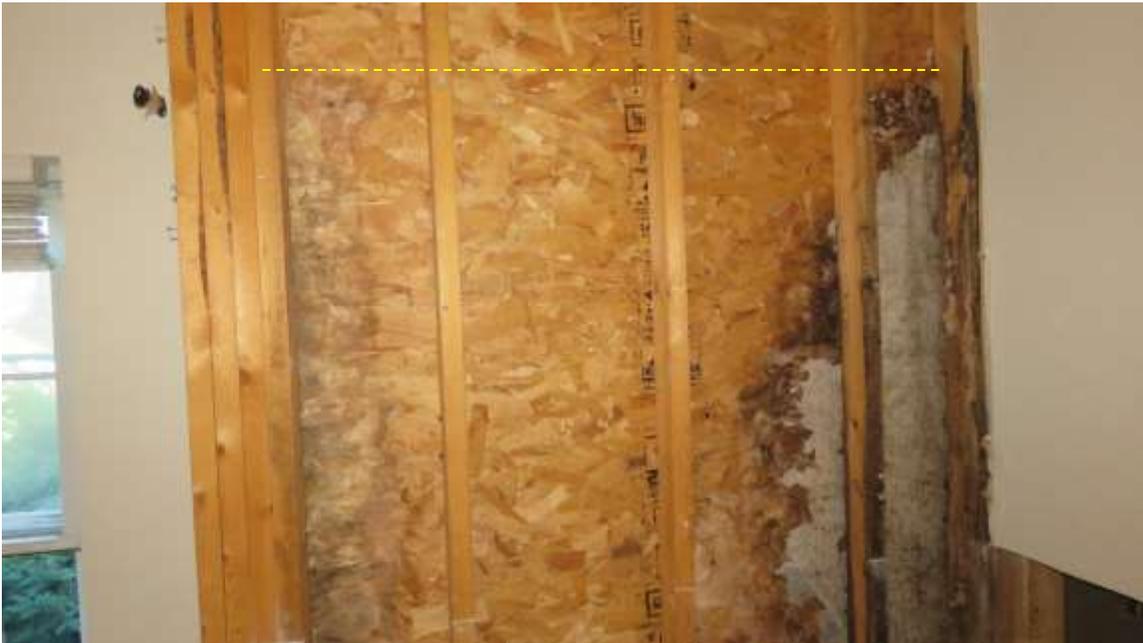
Photograph 20: Discoloration and deterioration of the wall sheathing.

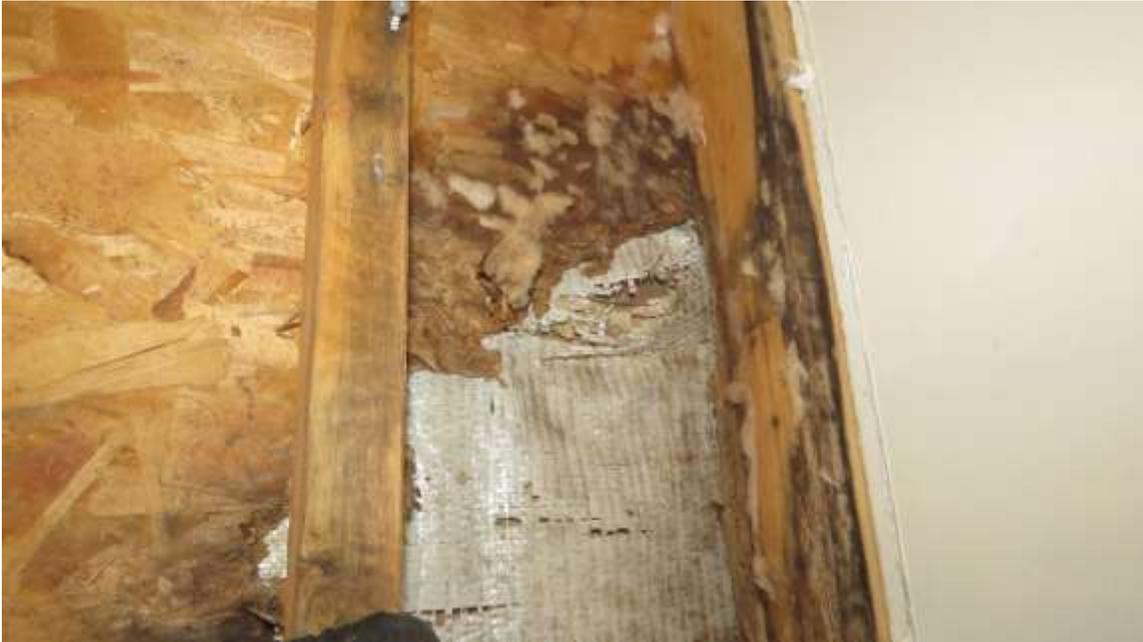
Photograph 21: Deterioration of the sheathing.

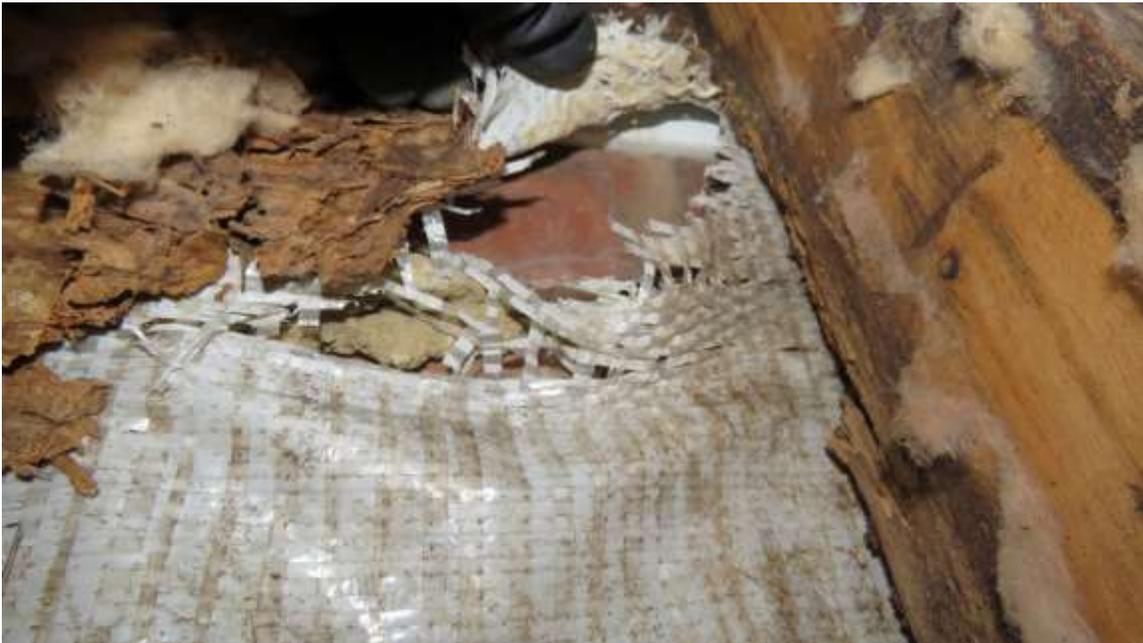
The primary cause of water intrusion into the building is improper installation of the brick veneer and deficient flashing around the top and sidewalls of the brick veneer. The brick veneer and mortar bed are directly in contact with the fabric house wrap, lacking the required air void. The air void can be negated if the house wrap is replaced with a water-resistant barrier; however, that was not done in this case. The wall also lacks weepholes and flashing within the wall cavity to shed water away from the sheathing. In addition, no brick ties are between the brick veneer and the wall sheathing, allowing for differential displacement of the wall claddings. This differential movement has allowed the flashing to bind against the back of the wall, resulting in the rotation of the flashing. The rotation forces water to drain to the ends of the wall section, penetrating the wall through the corner and end wall transitions where the veneer intersects the vinyl siding. Since the end walls lack additional flashing to deflect this water away from the wall, the water penetrates the wall envelope, saturating the OSB and the interior cavity of the wall.

Photograph 22: The deterioration coincides with the top of the brick veneer and flashing.

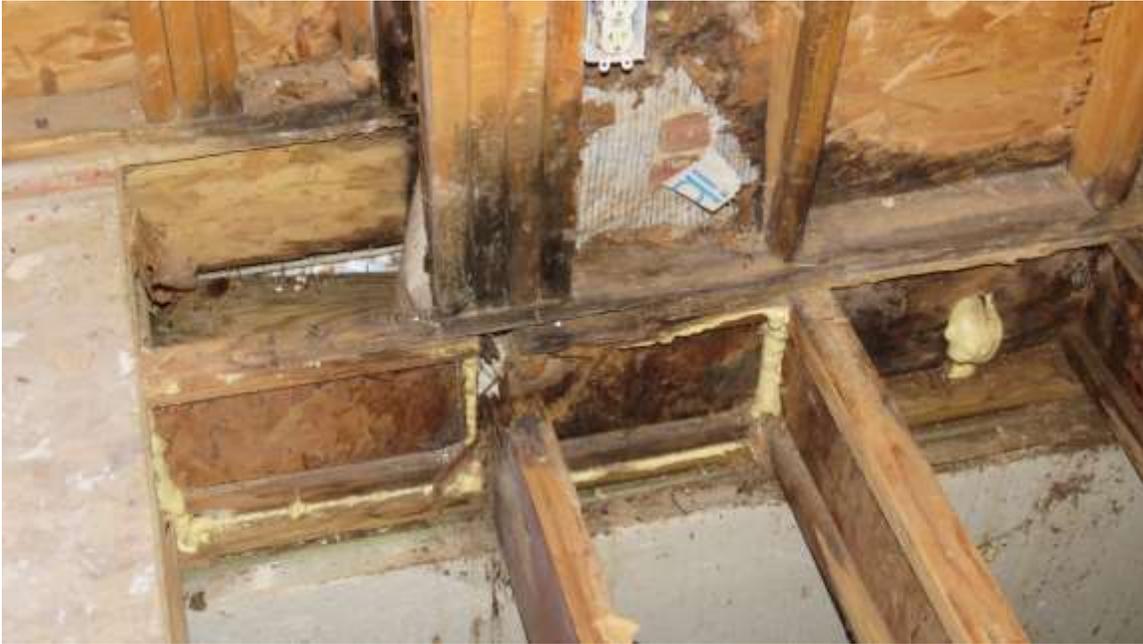
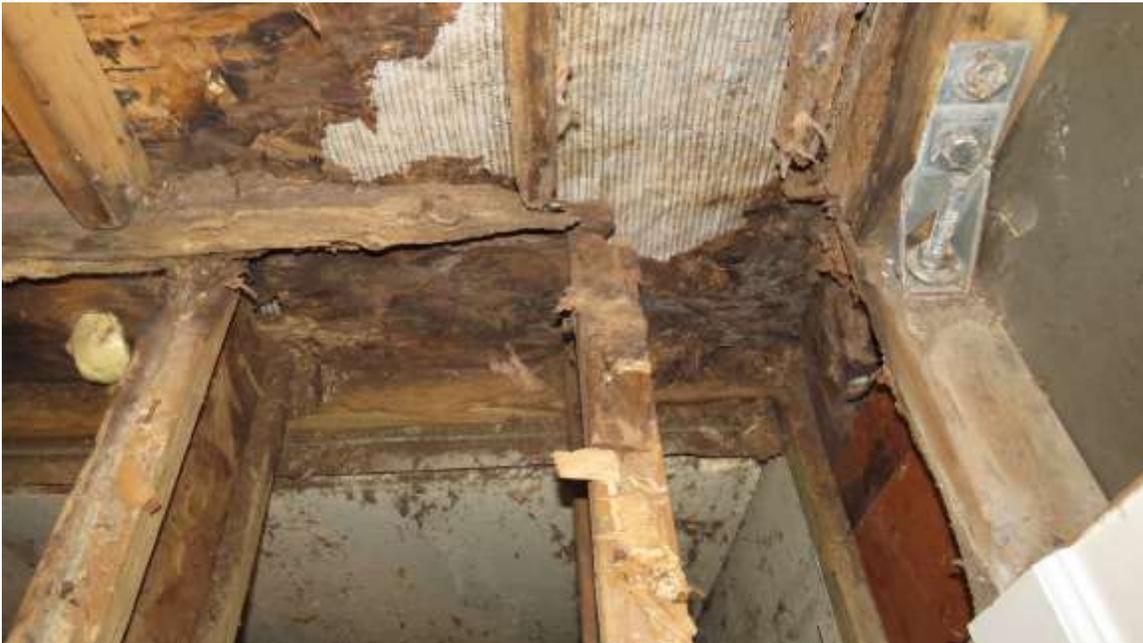
Photograph 23: Deterioration of the floor framing at the base of the wall.

Photograph 24: Deterioration of the floor framing at the base of the wall.

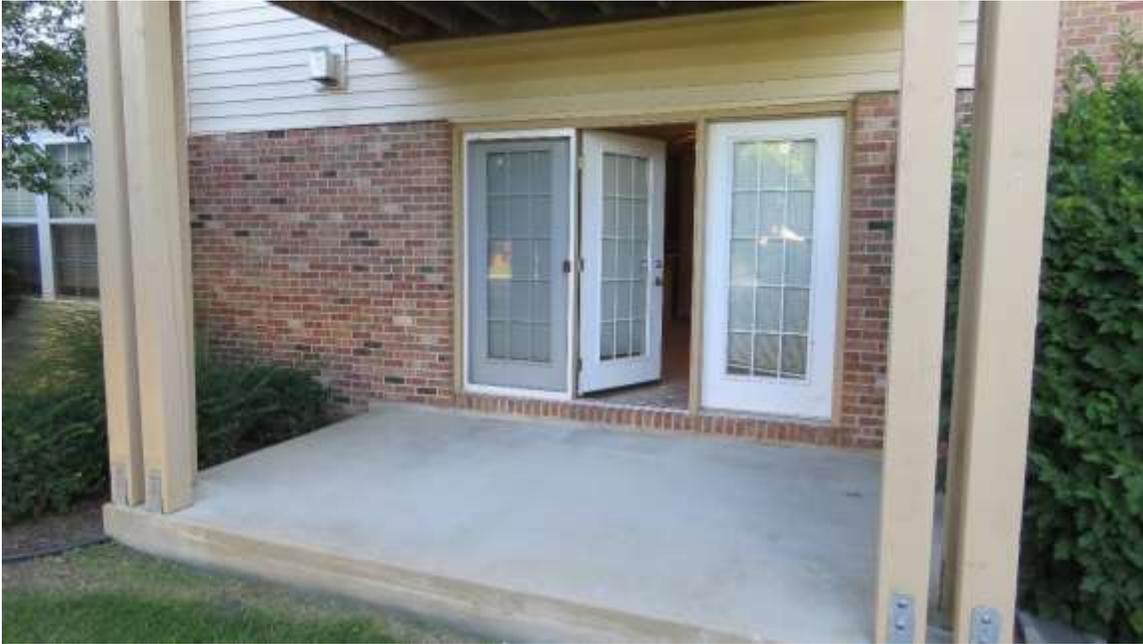
On the patio, the patio door is framed out with vinyl siding overhead, and brick veneer to the north and south (Photograph 25). The doorframe is discolored over the door, and at the bottom right (south) and bottom left (north) corners of the doorframe and trim (Photographs 26 through 29). The top right (south) and bottom left (north) corners of the outer framework of the patio windows adjacent to the door are discolored, and the paint is split and peeling (Photographs 30 and 31). The flashing over the brick veneer to both sides of the door is bent upward exposing the top edge of the brick across the exterior face (Photographs 32 and 33). From above, the flashing laps with the siding below the top edge of the brick, forcing the flashing to rotate upward off the top of the brick (Photograph 34). The J-channel over the flashing is also forced upward on the end of the doorframe, creating a low point over the door and gaps between the J-channel and door trim (Photograph 35). The sealant applied between the brick veneer and the wood trim on the outer face of the door is separated along the vertical corner.

Photograph 25: Overview of the patio and patio doors.

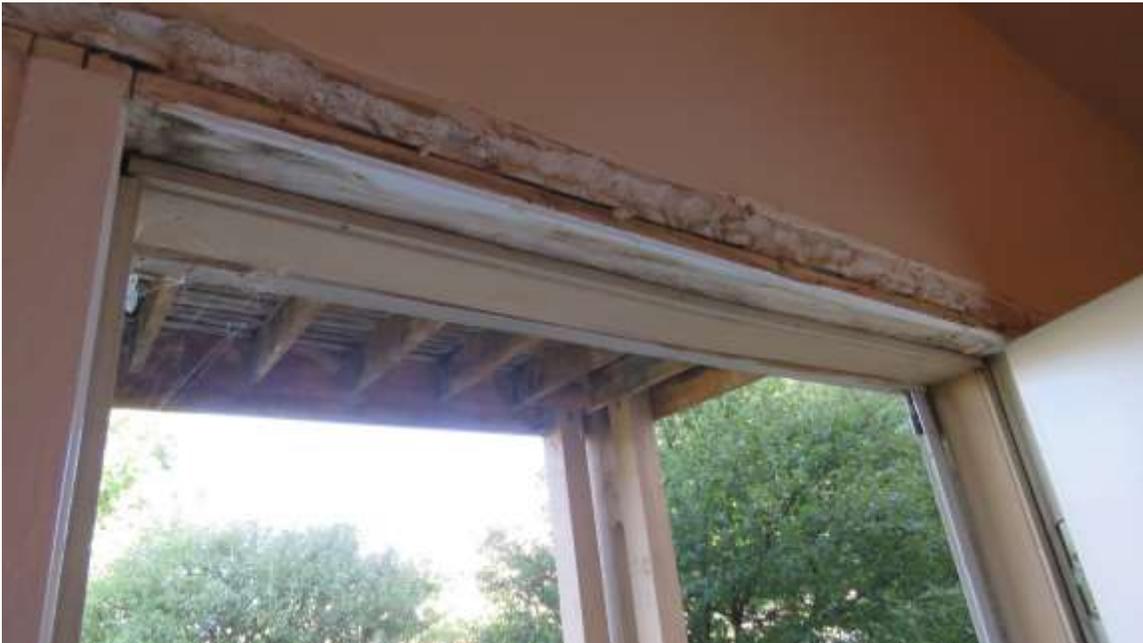
The same scenario is noted around the patio doors; however, in these locations, the flashing deflects water into the separation over the doorframe. This allows water to enter the wall through the top of the frame, passing down the sides of the frame to the floor.

Photograph 26: Discoloration of the framing over the door.
