DONAN[®]

MS. MYRNA WEBBER
COBBLEFIELD POINT CONDO ASSOCIATION
3858 THORNHILL CIRCLE
CHAMPAIGN, ILLINOIS 61822
CLAIM NUMBER: 3187291
DONAN PROJECT NUMBER: 13-18080194-0

SEPTEMBER 7, 2018

At your request, on September 5, 2018, a study was made on the condominium unit at the above-referenced address. The purpose of the study was to determine the cause of water intrusion on the exterior wall of the unit. Ms. Myrna Webber, a property manager with Devonshire Residential Management, was present to point out areas of concern and to provide firsthand information. Ms. Vicki Williams and Ms. Paula Goebel, members of the Cobblefield Point Condo Association board, were both present during the site visit. This letter, with the enclosed photographs, is the report of my findings and conclusions.

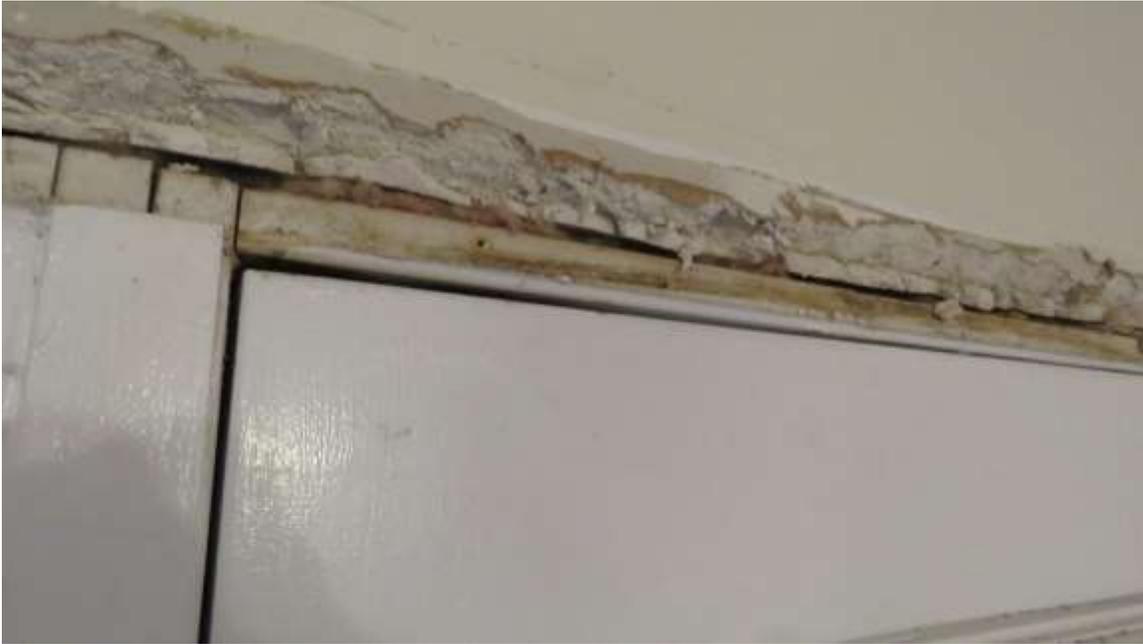
Photograph 27: Discoloration of the framing over the door.

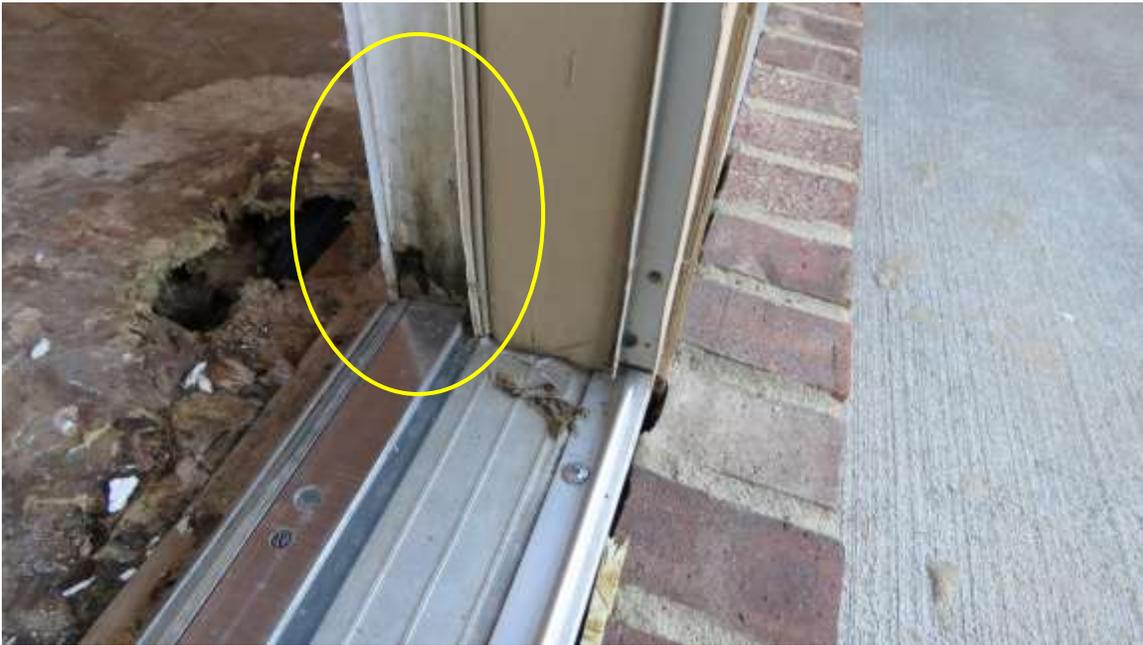
Photograph 28: Discoloration of the doorframe.

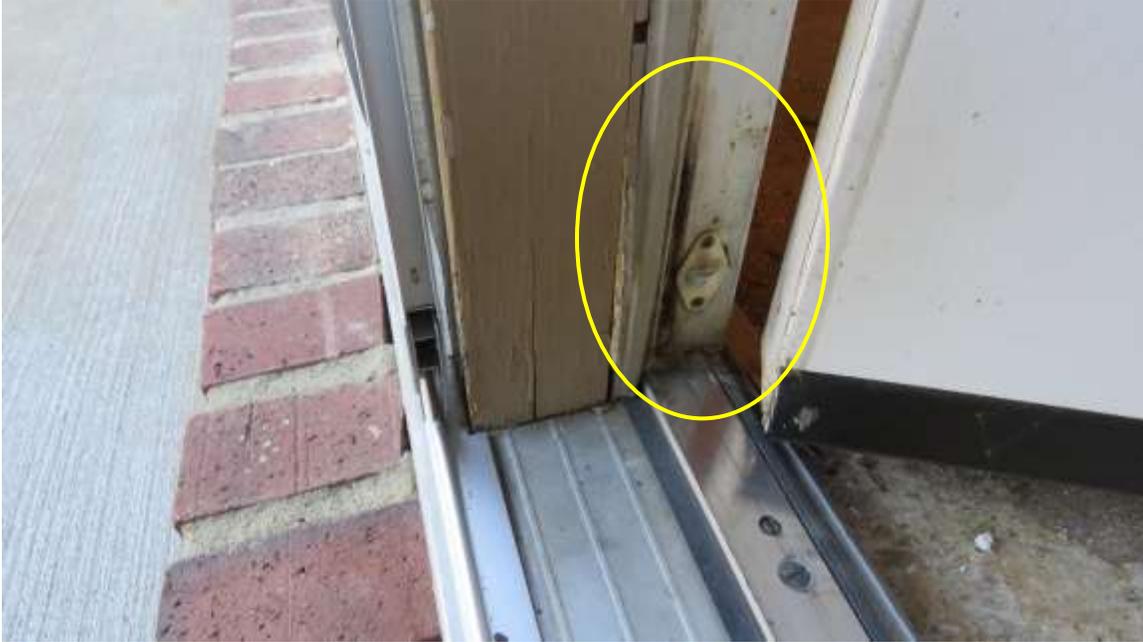
Photograph 29: Discoloration of the doorframe.

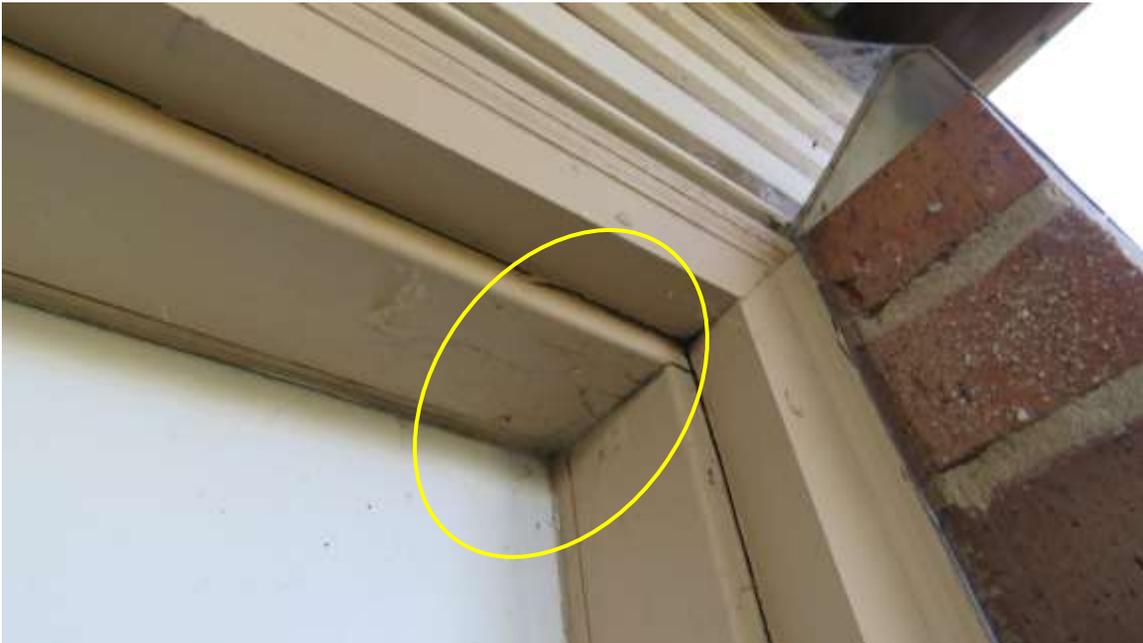
Photograph 30: Discoloration of the doorframe.

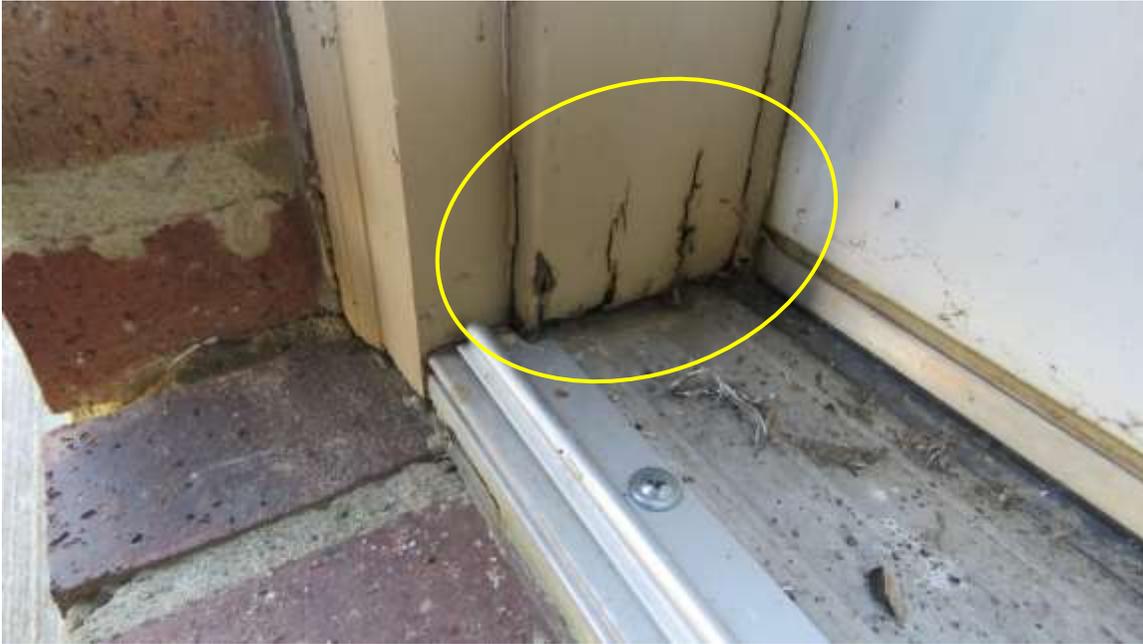
Photograph 31: Discoloration of the doorframe.

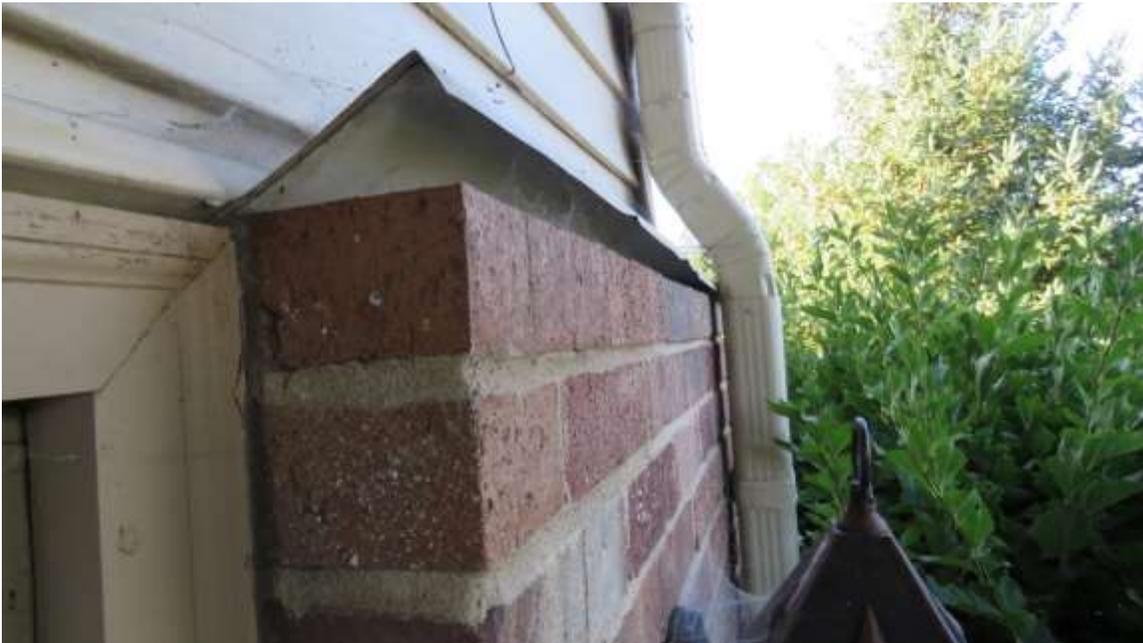
Photograph 32: Displacement of the veneer flashing.

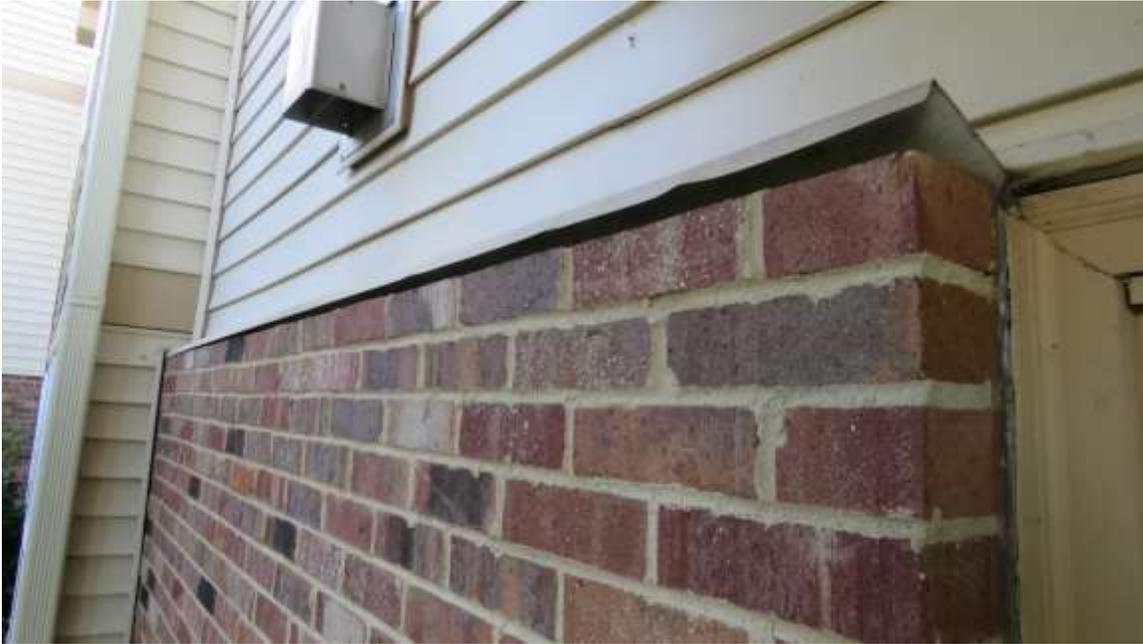
Photograph 33: Displacement of the veneer flashing.

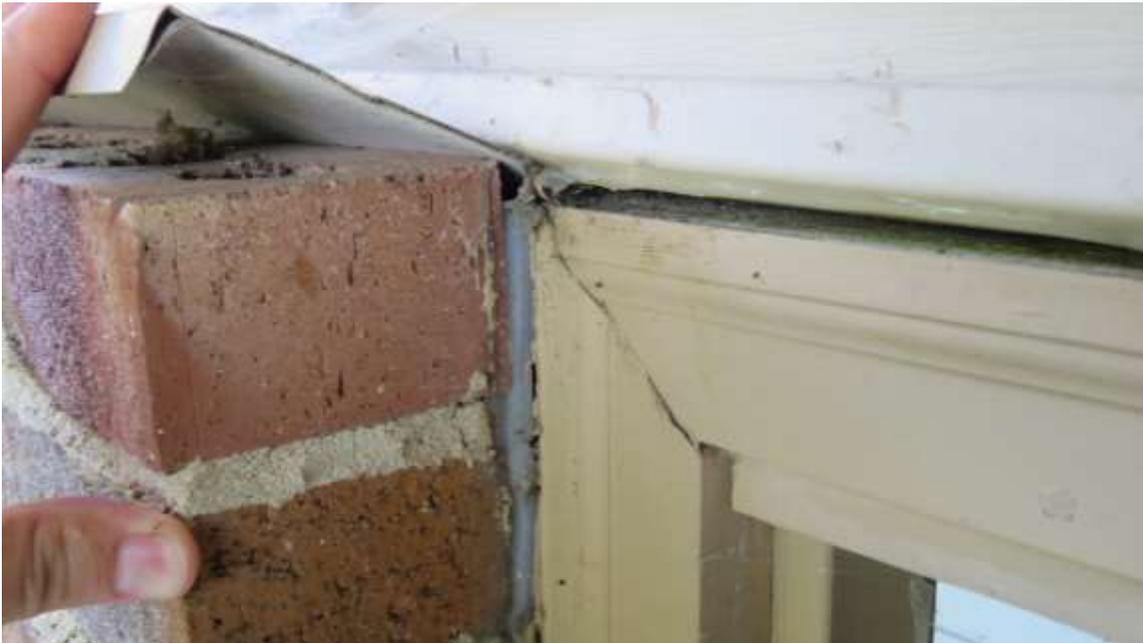
Photograph 34: Displacement of the veneer flashing, rotated upward and binding at the backside of the veneer.

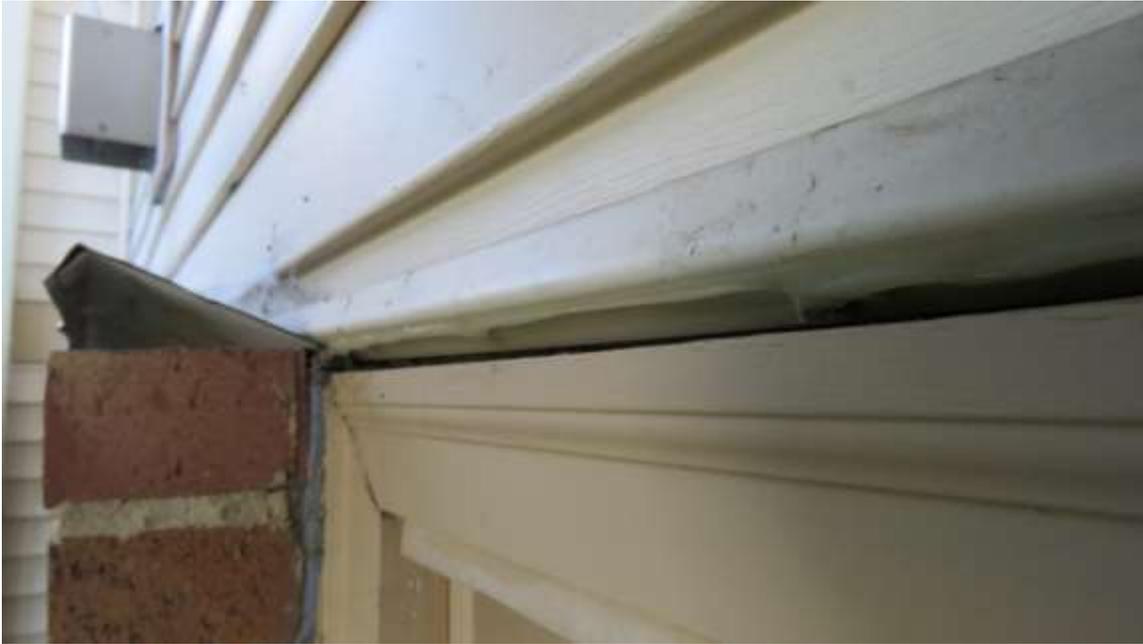
Photograph 35: Gap between the frame and the J-channel.

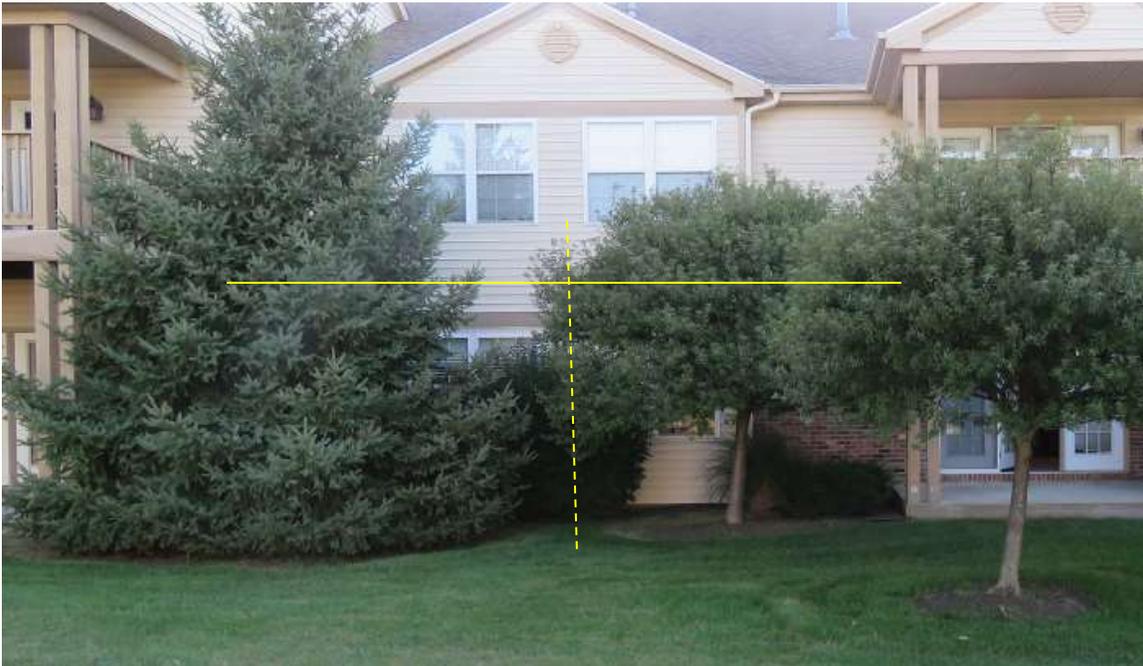
The brick veneer on the exterior of this unit is approximately 8 feet above the finished grade. The exterior walls outside the bedrooms are partially covered in vinyl siding, and partially covered with the brick veneer. The transition is at the approximate midpoint of the west wall in both bedrooms, with the interior wall separating the two bays of windows as seen on the exterior (Photograph 36). The vinyl siding to the south side (at the middle bedroom) and to the north (at the north bedroom) of the bump-out section of the wall is not firmly backed and moves inward when light hand pressure is applied (Photographs 37 and 38). The vinyl siding easily separates from the corner molding, and debris falls to the ground when pressure is applied (Photograph 39). A gap up to ¼ inch is between the siding and the veneer at these corners, and the fabric house wrap is visible in the separation (Photograph 40). At the top of the veneer, the metal flashing is rotated upward through the midsection, and drops within ¼ inch of the top of the wall at the corners (Photographs 41 and 42). Algae stains and debris is along the back (house) side of the flashing under the J-channel (Photograph 43).

Photograph 36: Exterior wall outside the bedrooms. Solid line indicates the height of the veneer, while the dashed line indicates the separating wall between bedrooms.

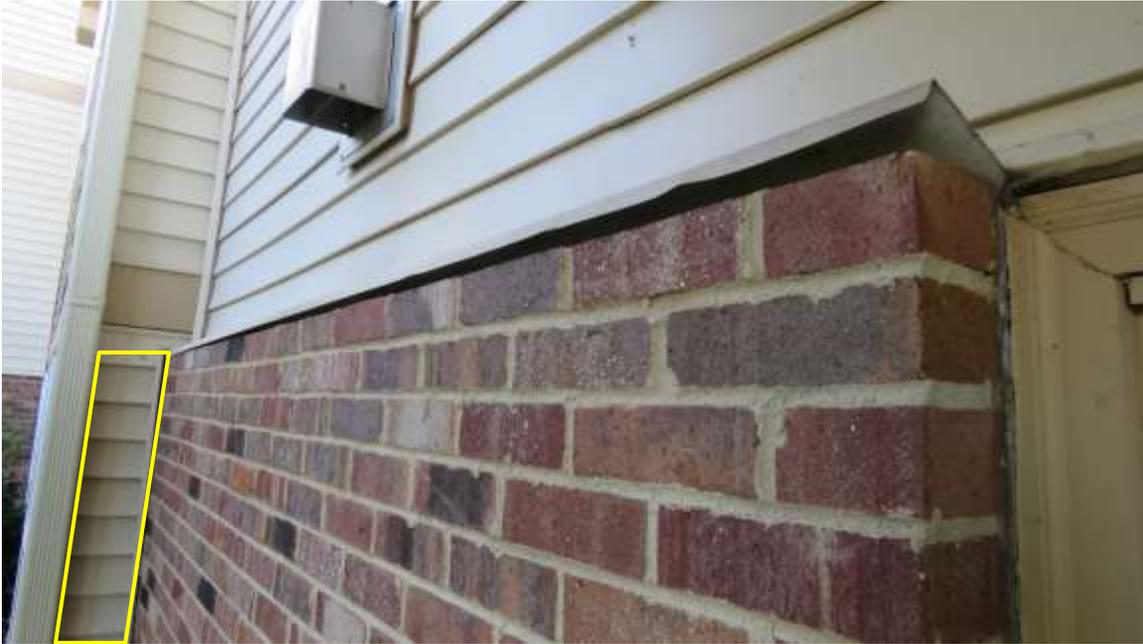
Photograph 37: Veneer to vinyl intersection to the south at the bedrooms. Soft area is outlined.

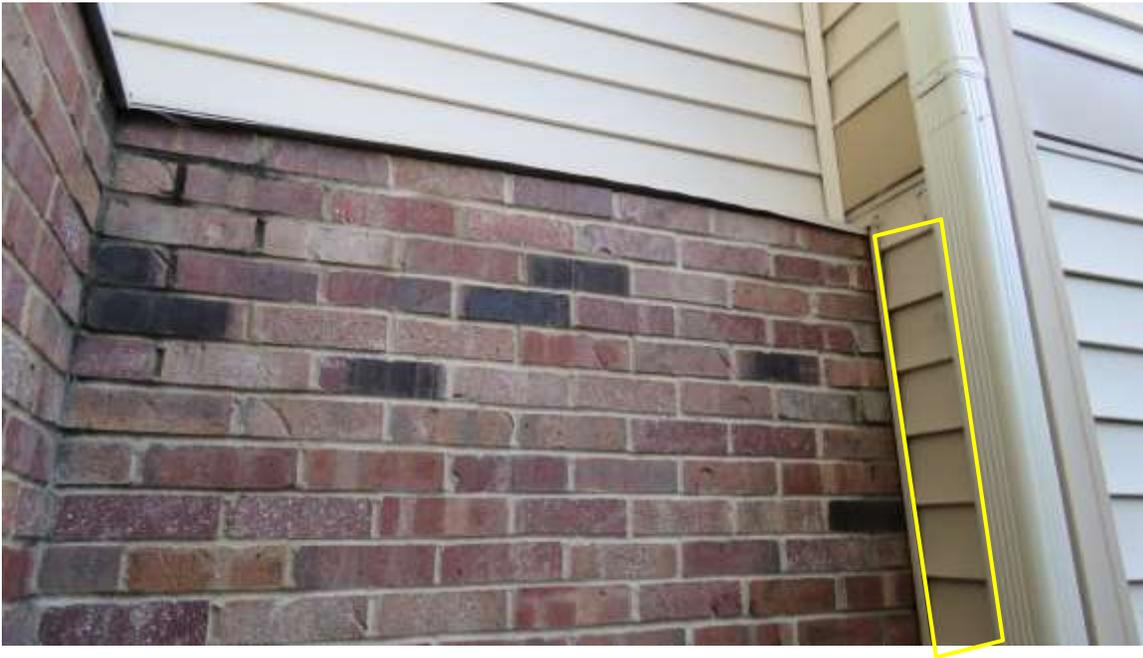
Photograph 38: Veneer to vinyl intersection to the north at the bedrooms. Soft area is outlined.

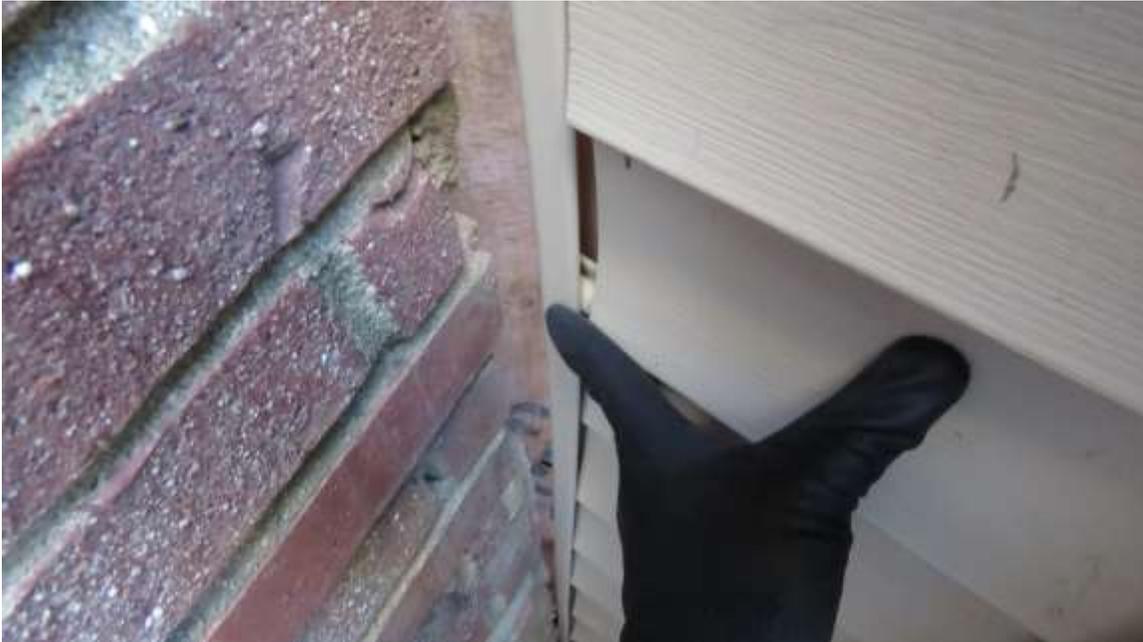
Photograph 39: Gaps between the vinyl siding and the brick veneer at the interior corners.

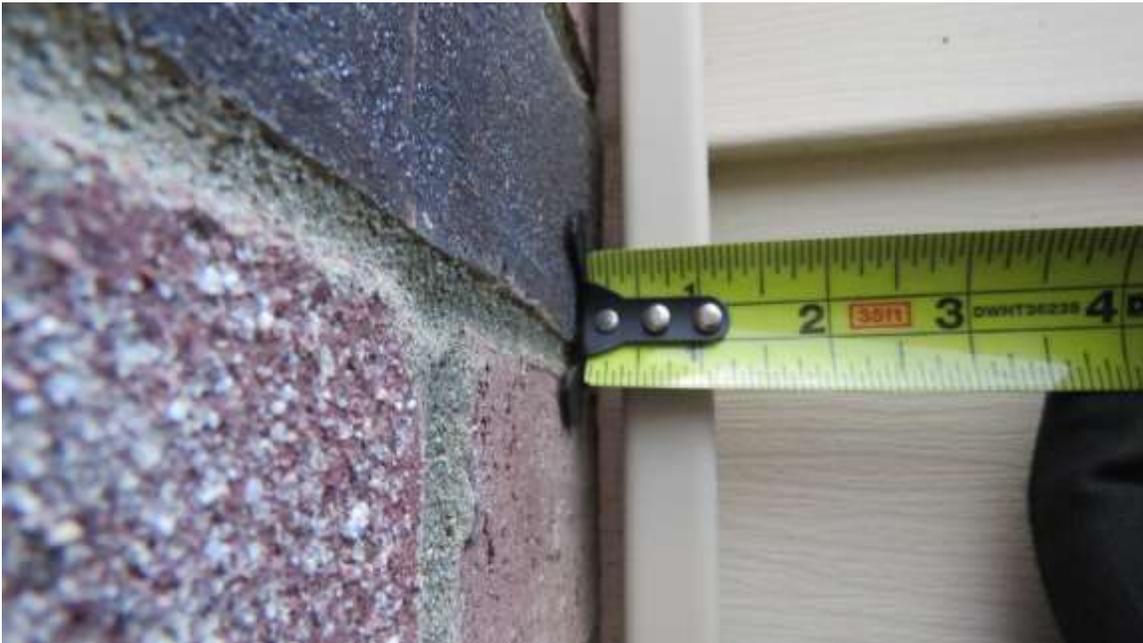
Photograph 40: Gaps between the vinyl siding and the brick veneer at the interior corners.

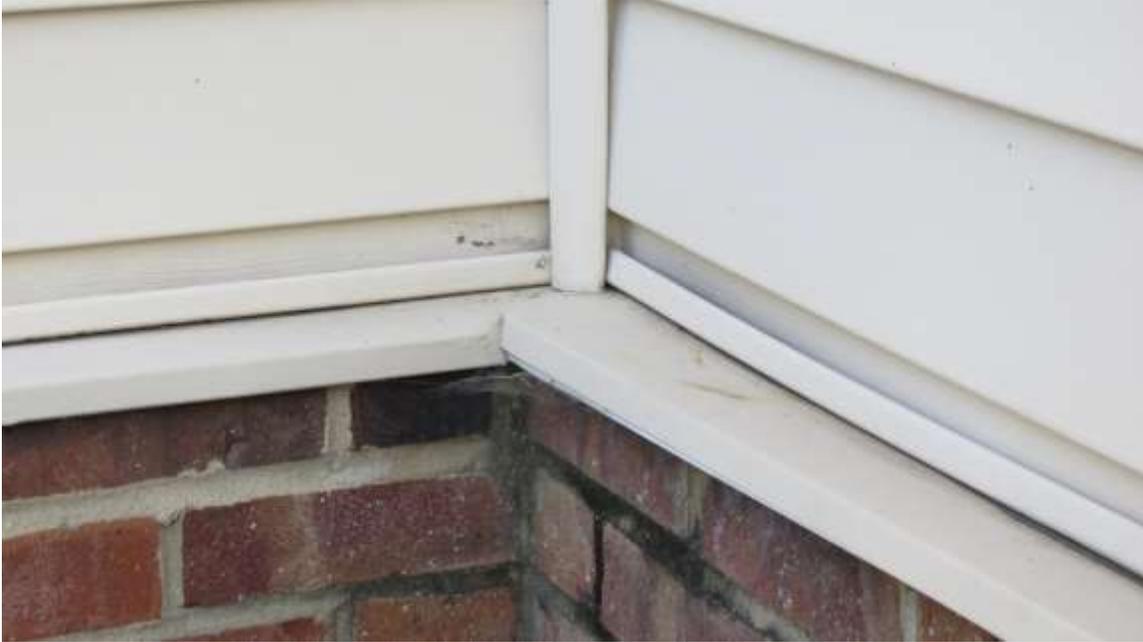
Photograph 41: Gaps in the flashing at the low spot over the interior corner.

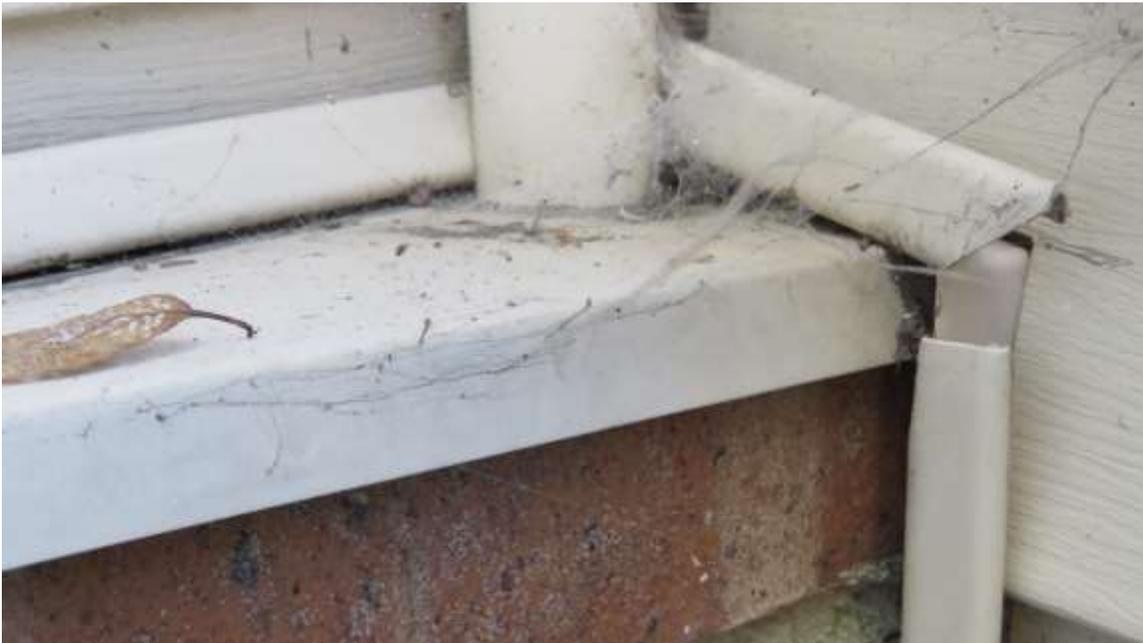
Photograph 42: Low-spot at the end of the flashing at the end, terminating behind the vinyl siding.

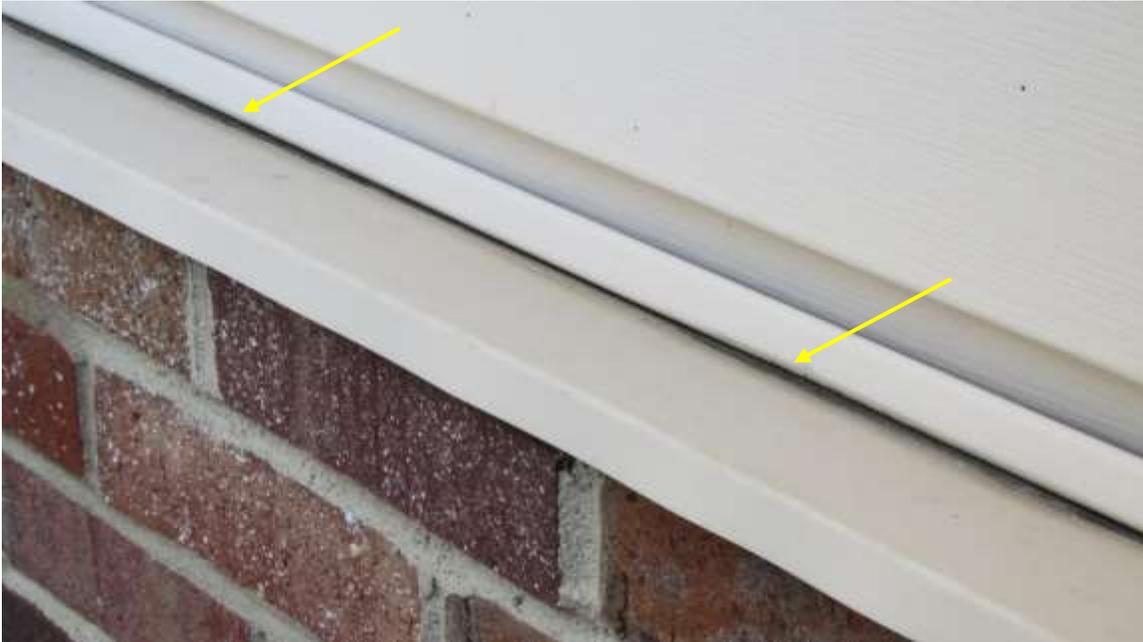
Photograph 43: Debris and algae-staining between the J-channel and flashing.

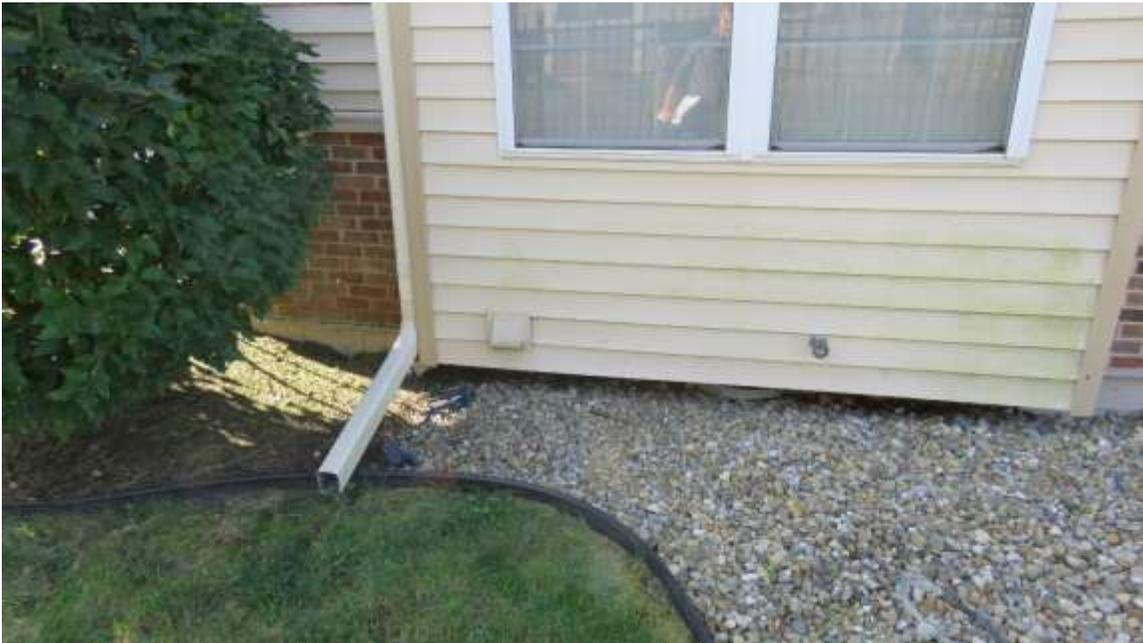
Ms. Goebel directed the study to the north exterior wall of her unit in building A3 to the north of the subject building. The north exterior wall of building A3 has brick veneer up to approximately 36 inches as opposed to 8 feet as on the previous building. The veneer capstone and flashing has been replaced with a capstone that slopes down away from the exterior wall. Gaps are between the J-channel and the capstone at the ends of the veneer wall (Photographs 44 through 46). The vinyl siding in this location, to the north of the Ms. Goebel's unit lacks solid backing and moves inward with light hand pressure (Photograph

Photograph 44: Overview of the north wall of the Goebel unit

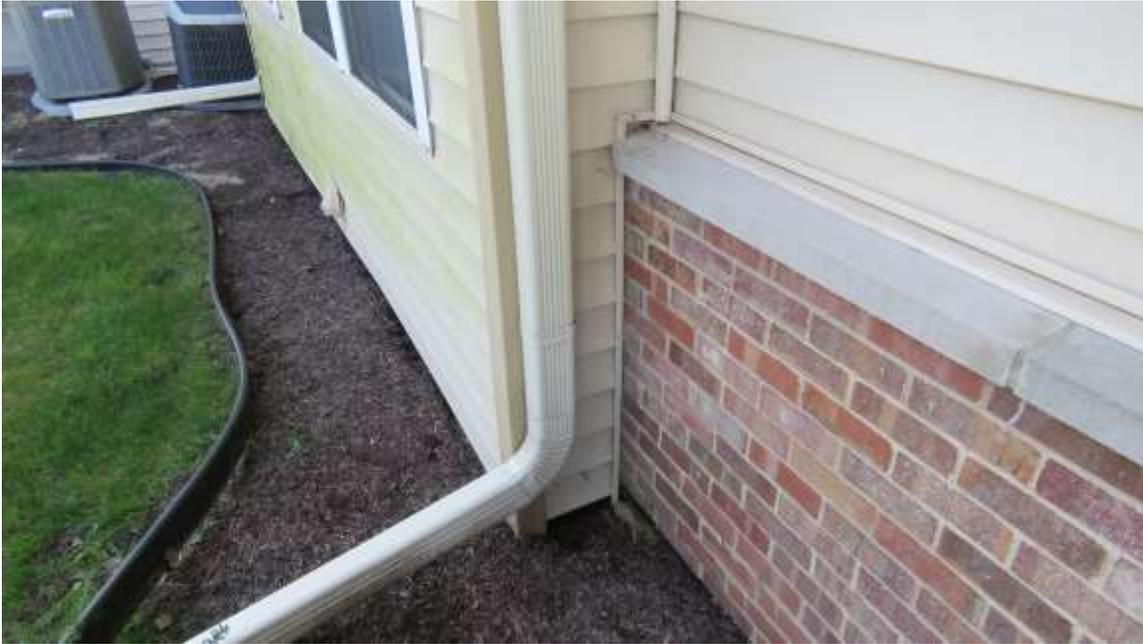
The brick veneer capstone was replaced to direct water away; however, the capstone terminates behind the vinyl siding. Without proper flashing to redirect water away from the wall sheathing, the water passing behind the sheathing at the corners can still saturate the framing. The siding (or interior drywall) can be removed for a more thorough inspection of sheathing.

Photograph 45: Short veneer wall terminates behind the vinyl siding.

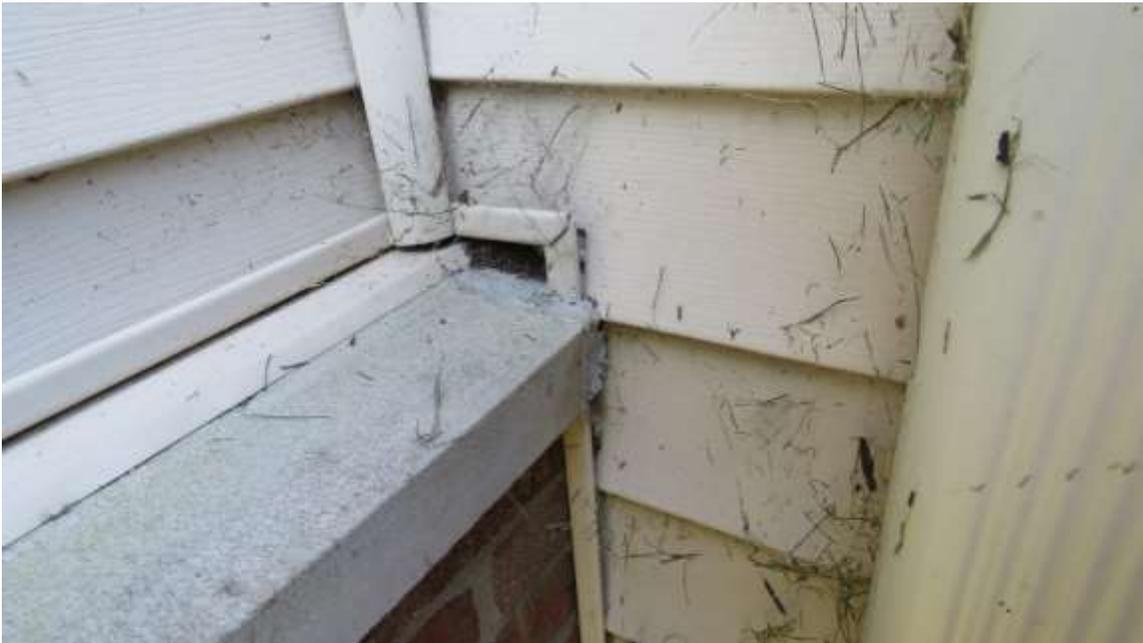
Photograph 46: Short veneer wall terminates behind the vinyl siding.

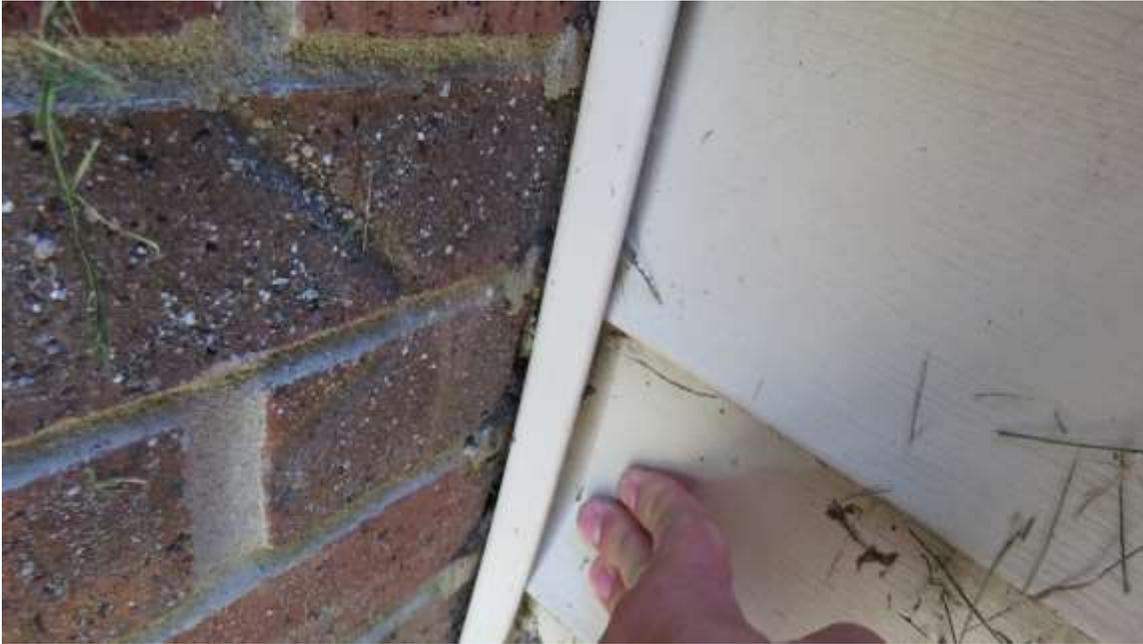
47). The brick veneer around the adjacent unit to the east (the east end unit in building A3) has been removed around the patio and replaced with vinyl siding.

On the north side of the adjacent building, the floor/wall framing and siding have reportedly been replaced due to a previous, but similar issue. The vinyl siding on the exterior Ms. Goebel’s unit flexed in a manner similar to that on the subject building, indicating that similar issues may still be ongoing within her unit.

Photograph 47: Flex in the wall behind the vinyl siding.
